HISTORIC STRUCTURE REPORT
for the
VALLEY GROVE CHURCHES
Nerstrand, Minnesota

prepared for the
VALLEY GROVE PRESERVATION SOCIETY

prepared by
MacDonald & Mack Architects, LTD.
400 South Fourth Street, Suite 712
Minneapolis, Minnesota 55415

September 30, 2013

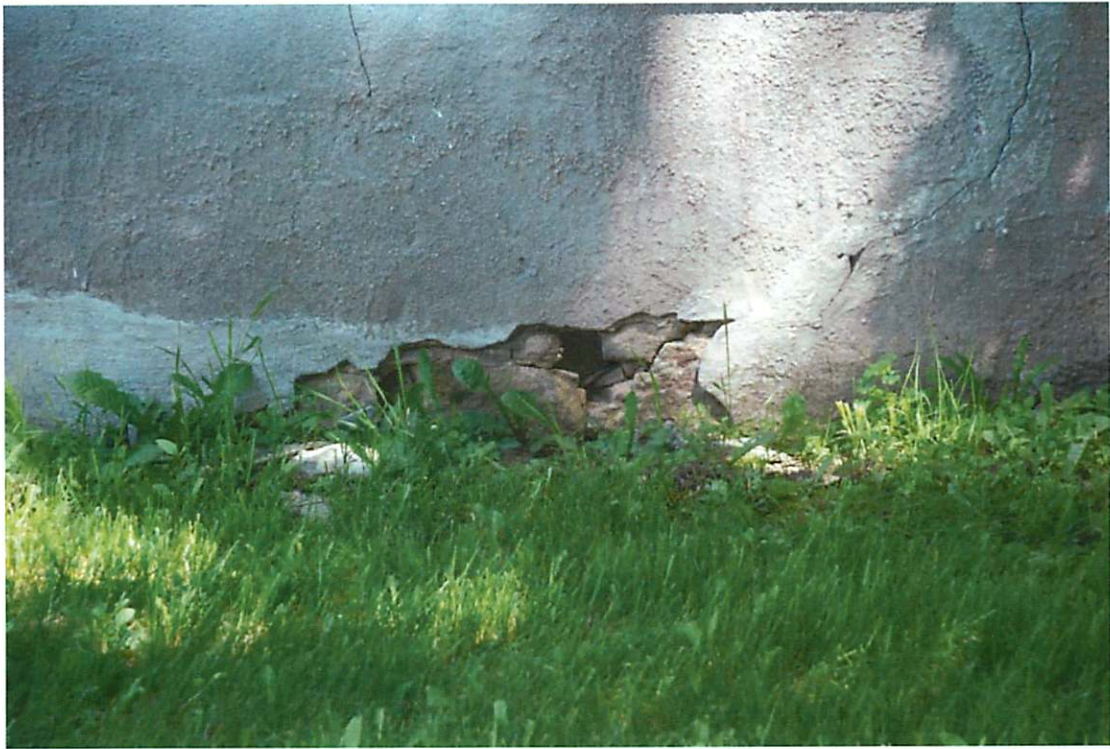
Assessment: The church has a rubble limestone foundation that is almost totally covered at the exterior with a cementitious parging. It is assumed that the parging is part of the repairs referenced below. The existing parging is mostly in good condition, although there are several areas where it is failing and the underlying limestone is exposed, (See Figure 3) At the west façade, there is deterioration of the stone.

Figure 3: Example of damaged parging at foundation wall. Note the deteriorated mortar joints behind the parging that should also be repaired.

Recommendations: Repair the areas of damaged parging by applying new parging that matches the existing, and address water control issues that may be contributing to the deterioration. If there are areas of exposed deteriorated mortar, it would be good to repoint the mortar before parging over it. There are no recommendations for the footings.

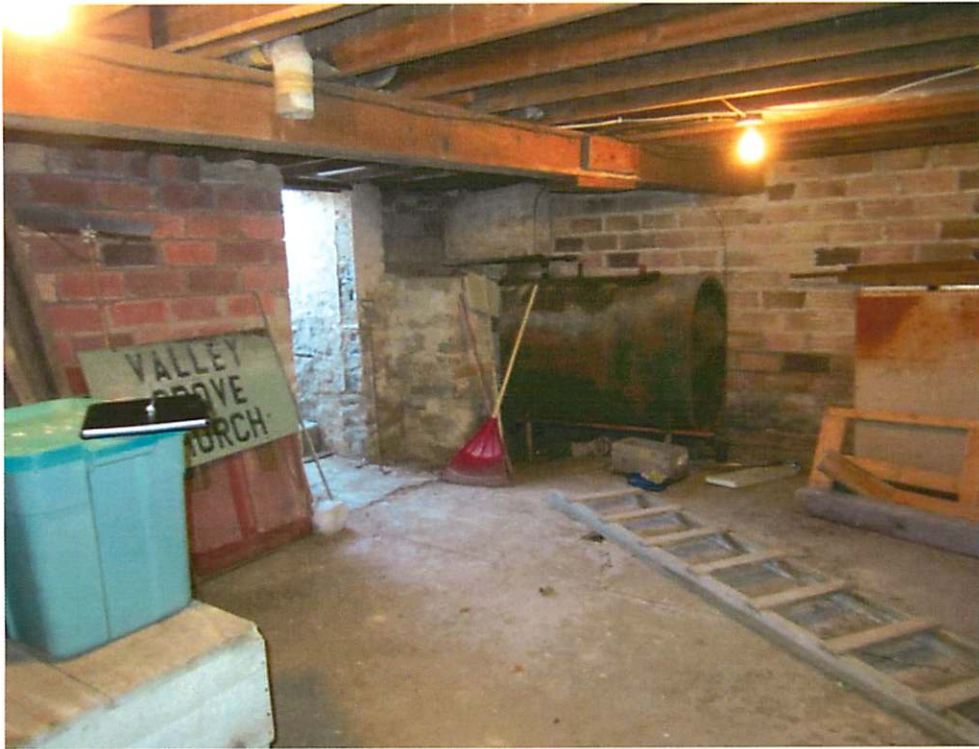
Assessment: Other than the limestone foundation, the basement has had some reinforcement work over the years with the addition of a concrete masonry unit wall, running the length of the structure and also the addition of a structural tile and brick wall. These walls provide additional support for the existing wood floor structure above. (See Figure 4)

Figure 4: Basement of Church showing masonry walls and floor structure.

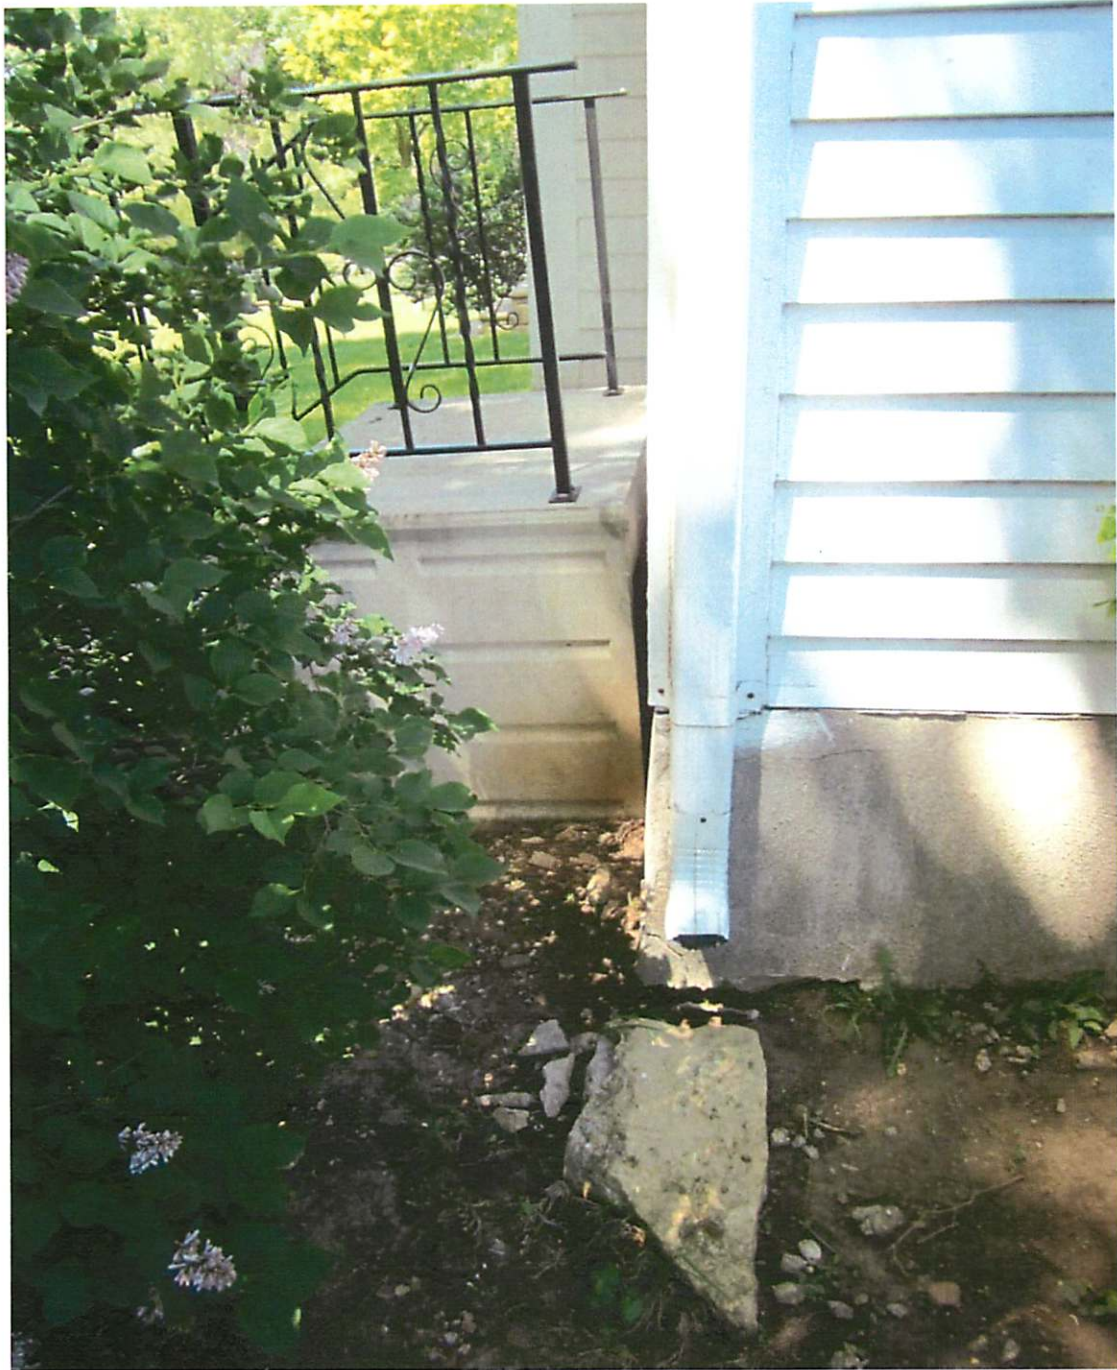
Figure 5: This photograph shows the precast concrete stair that is pulling away from the structure and the downspout that needs to be extended to move water away from the foundation.

Recommendations: No recommendations for the front stair. The rear stair should be set back in place.

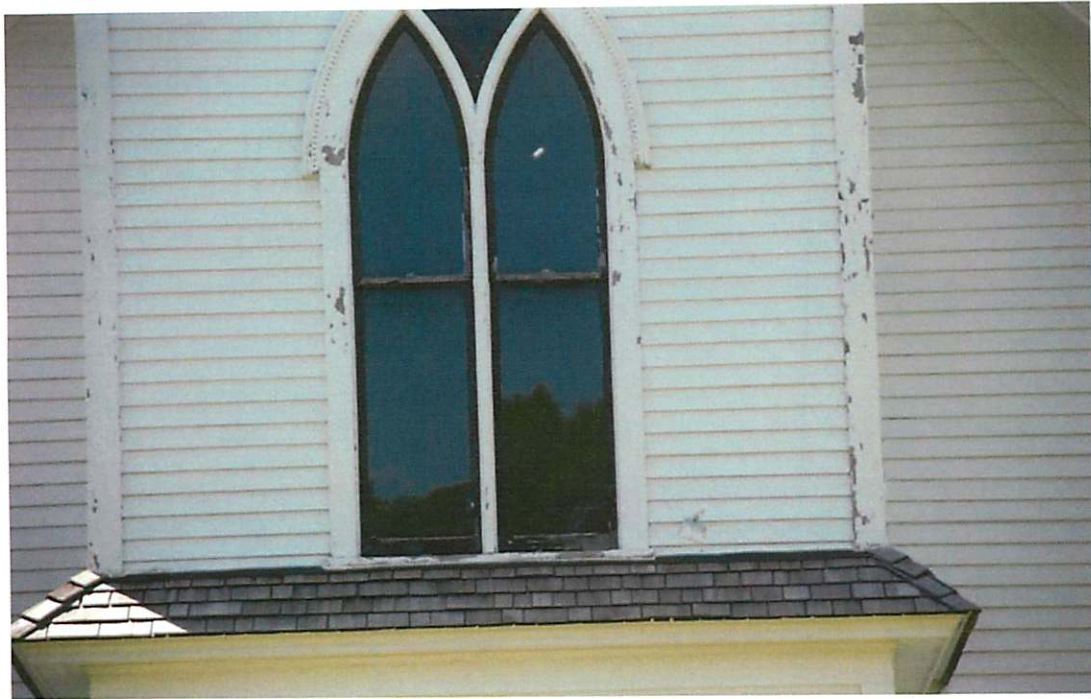
Figure 6: This photograph shows the deteriorated paint at the corner boards and window trim.

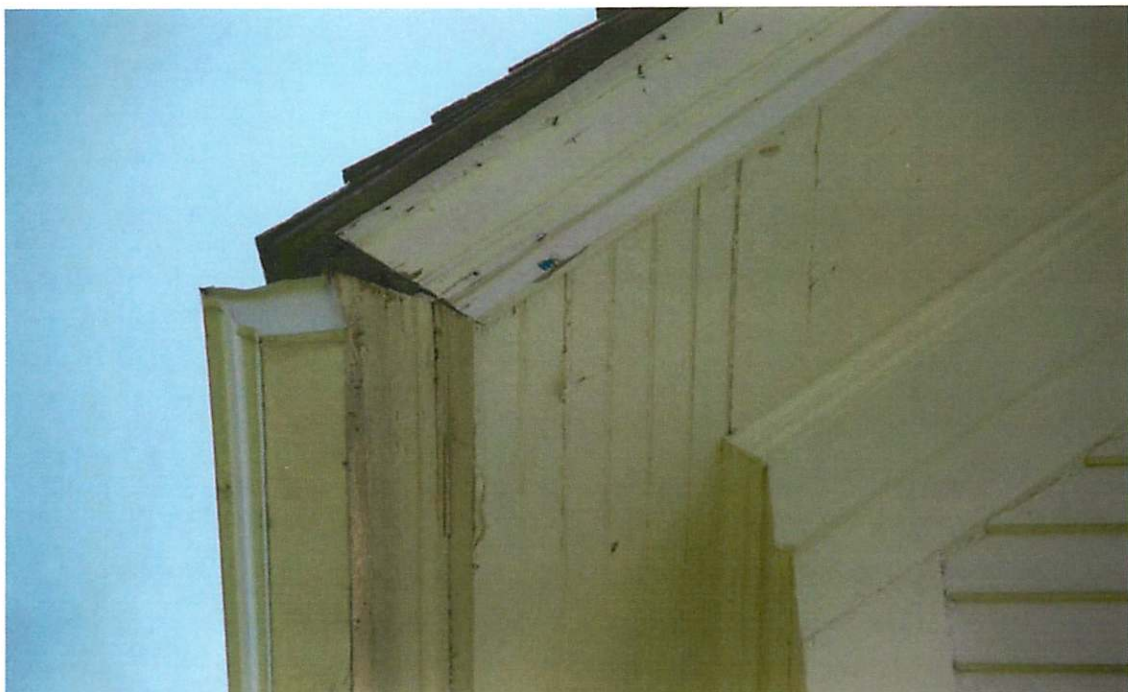
Figure 7: This image of the corner shows the trim pulling apart, at a location that is vulnerable to water infiltration.

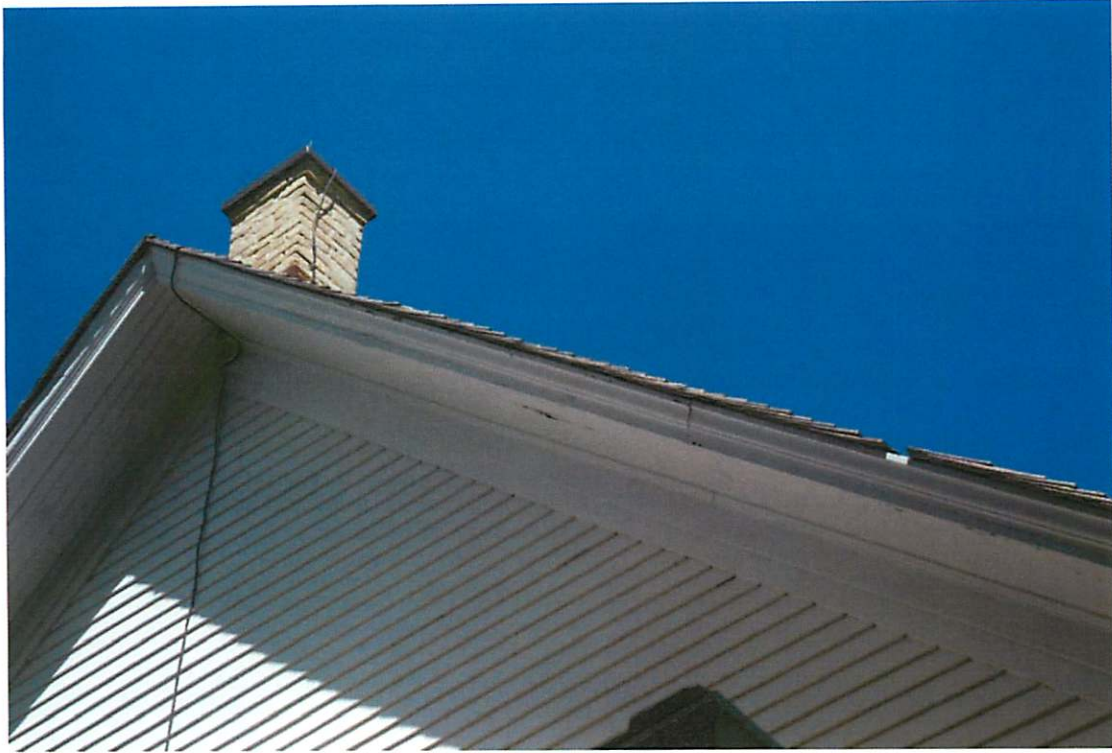
Figure 8: This photograph show a missing wood shingle at the roofs edge, and the masonry chimney.

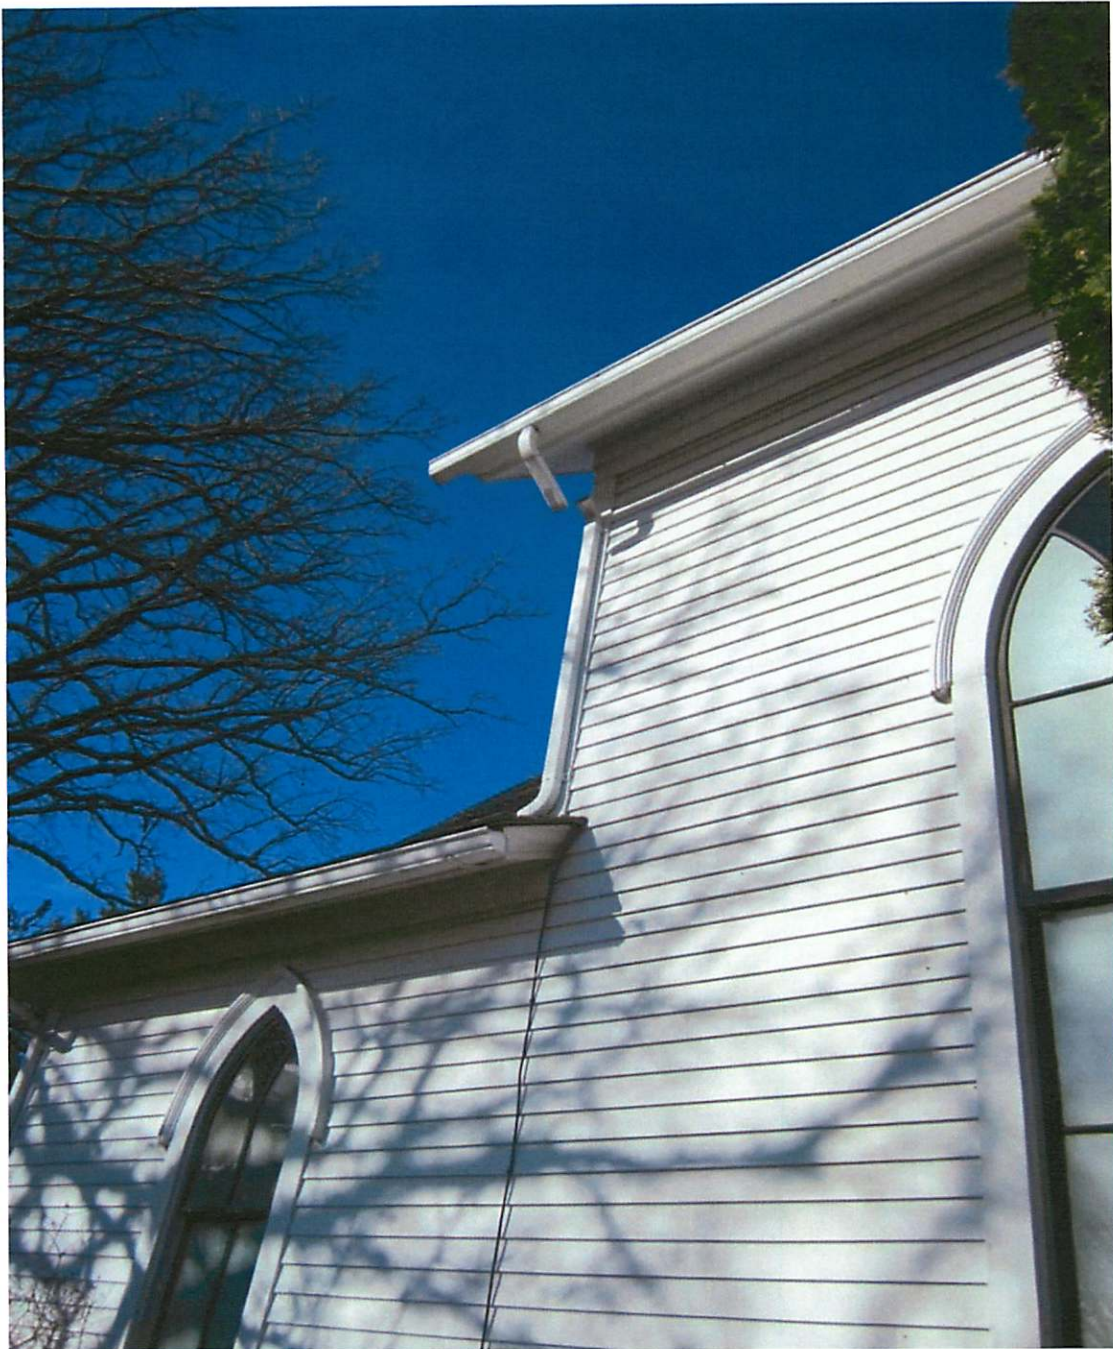
Figure 9: This photograph show the upper downspout that is not connected, allowing water to run down the siding.

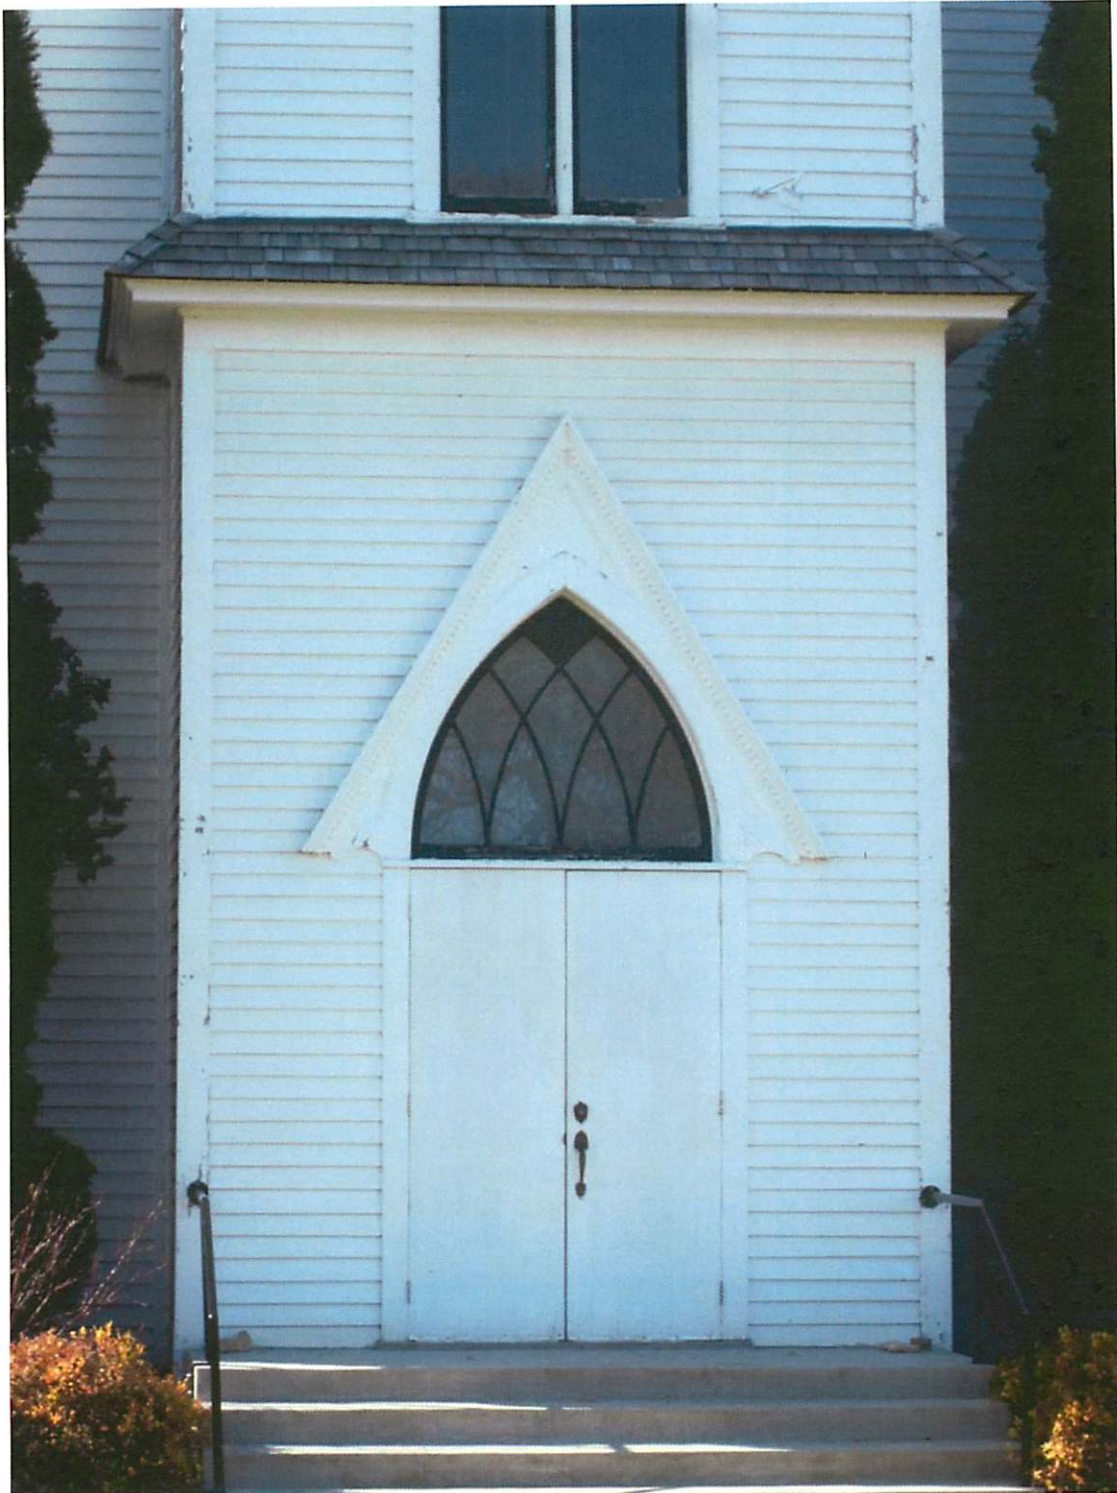
Figure 10: These are the front entry doors; there is damage at the bottom edge of each door leaf.

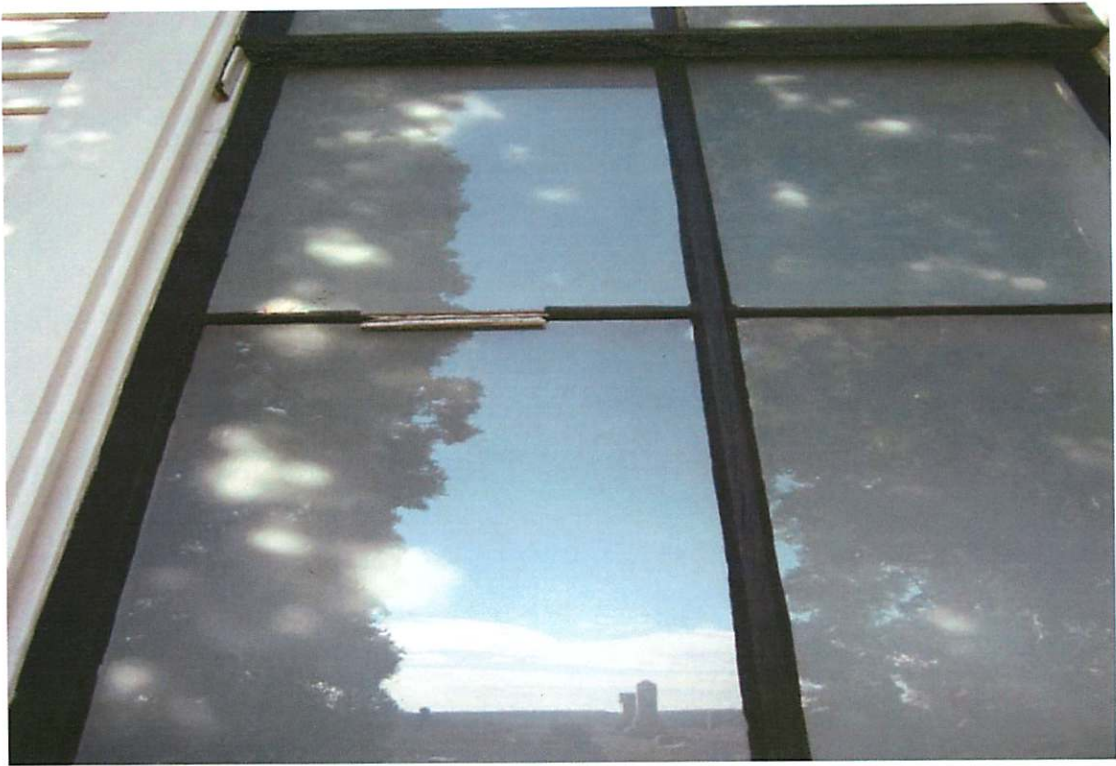
Figure 11: This photograph shows an broken muntin at one of the windows.

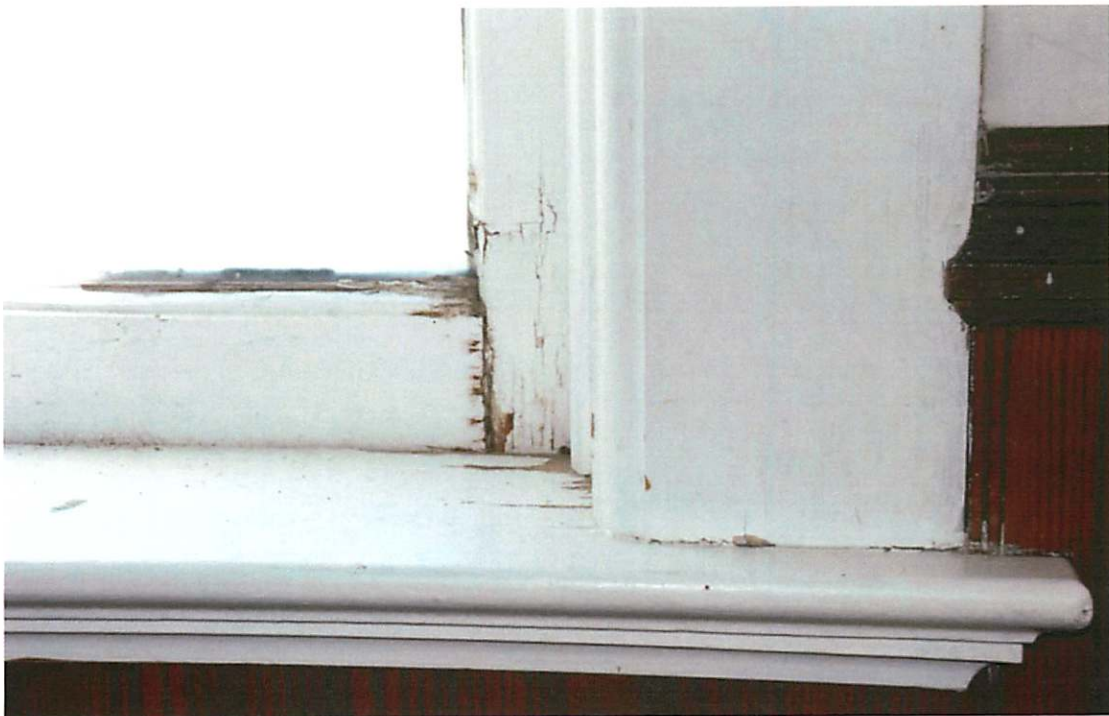
Figure 12: This photograph shows deteriorated paint and wood at an interior window.

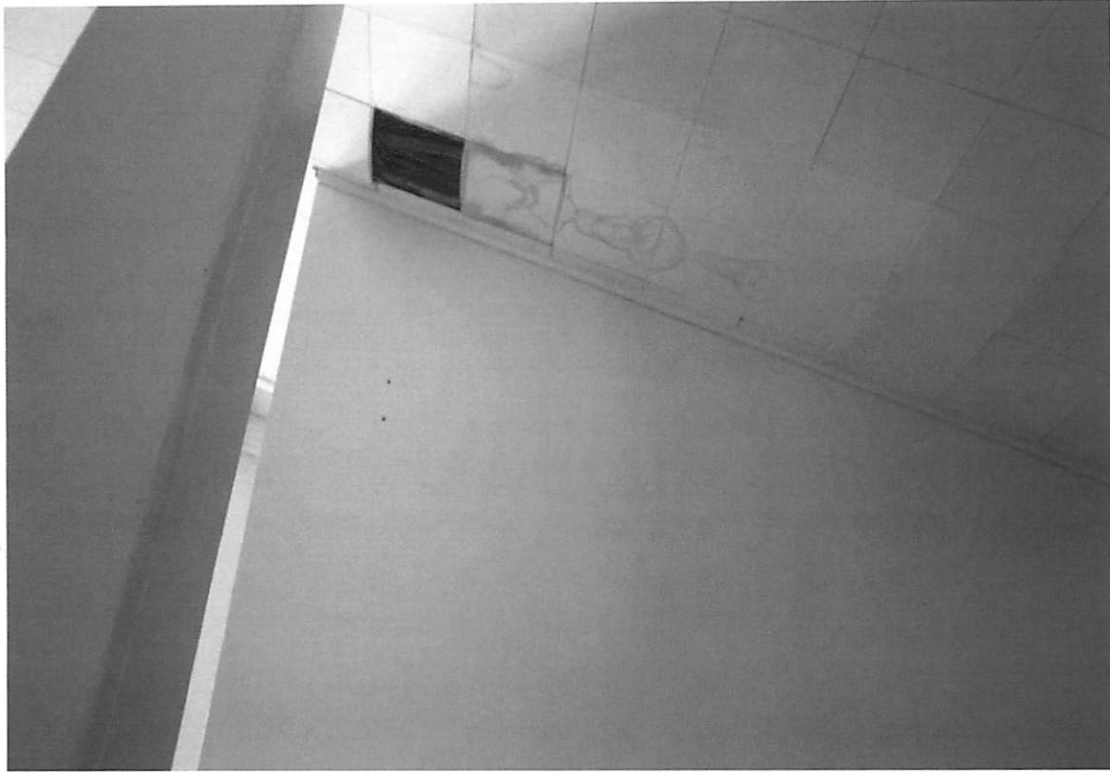
Figure 16: This photograph shows the ceiling condition in the balcony; missing ceiling tile and water damage.

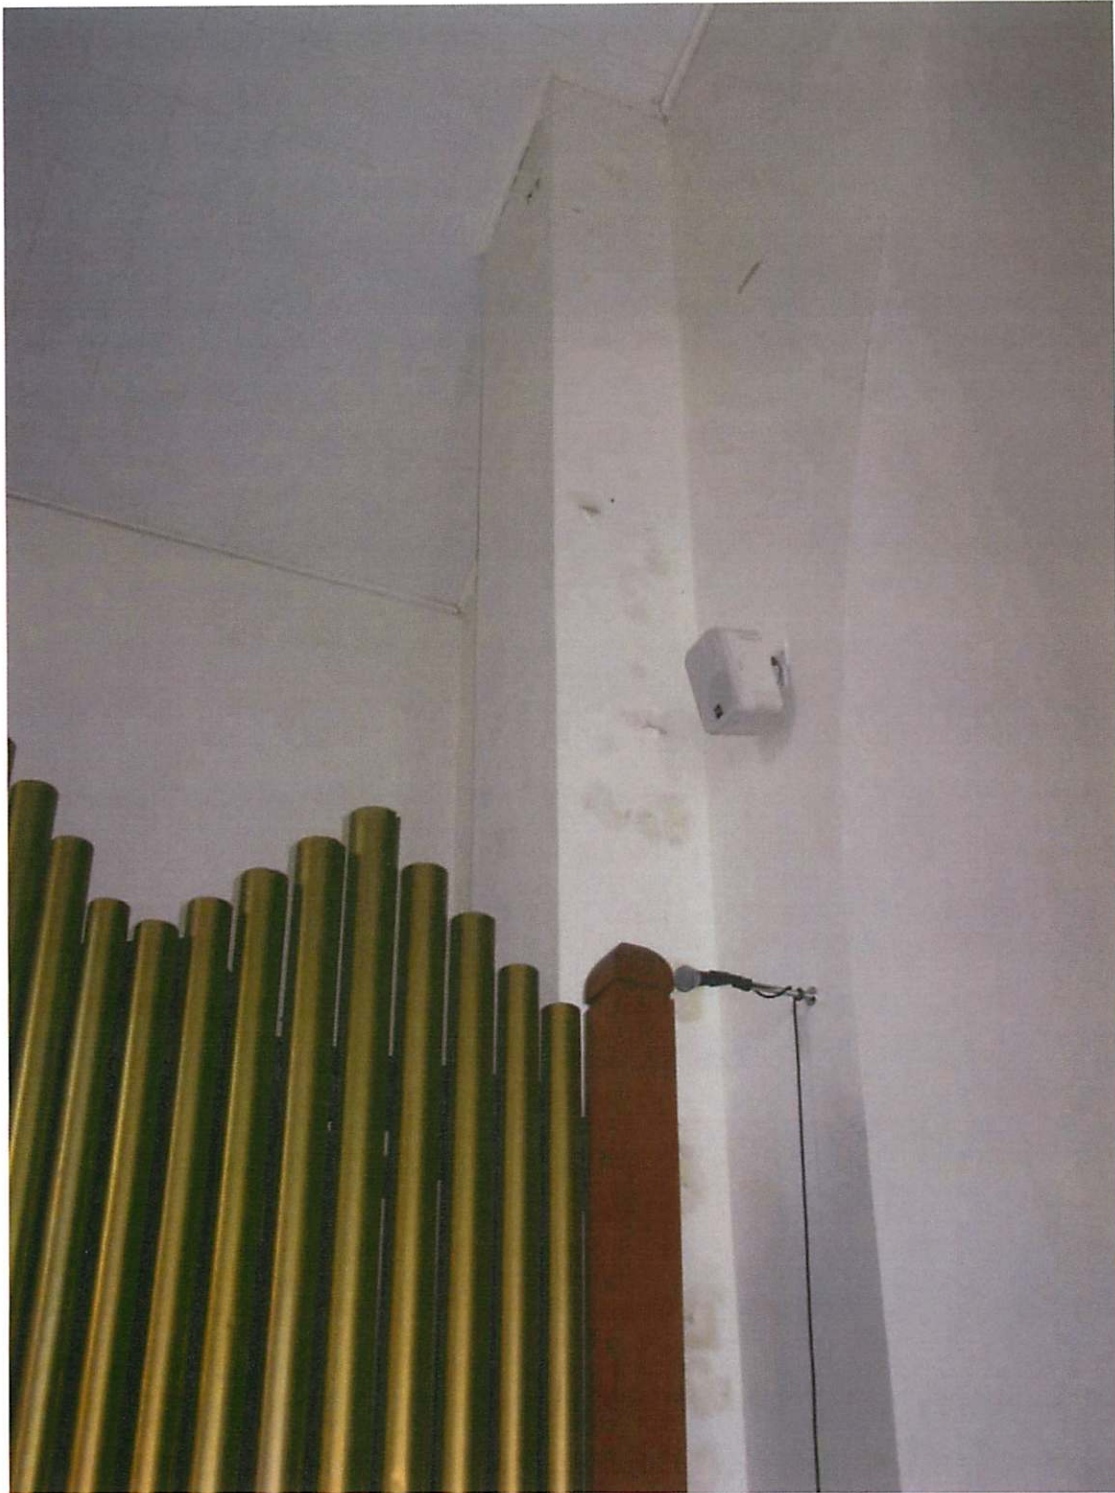
Figure 17: This photograph show the corner of the Sanctuary, near the organ, where the chimney comes through the space. There is damage on the plaster, due to condensation from the furnace.

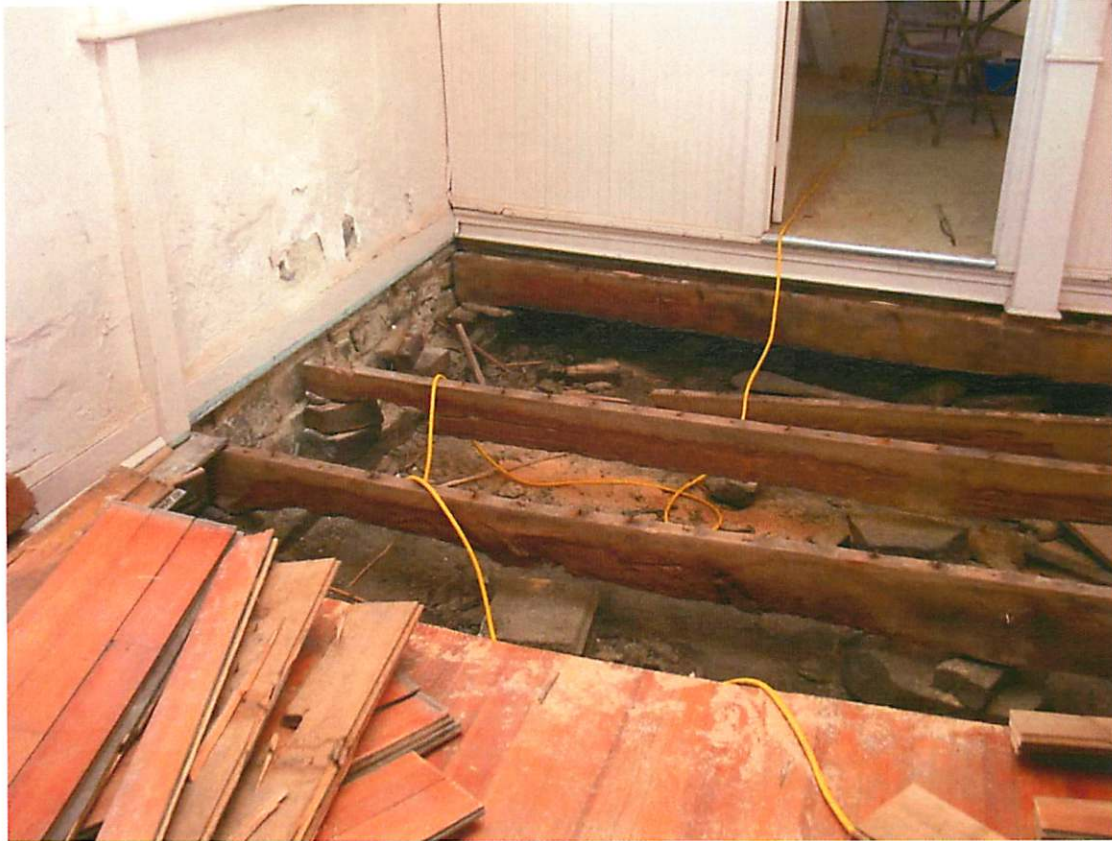
Assessment: Although no footings and foundations are visible at this time, photographs from the 2007 interior rehabilitation show that the foundation is constructed from rubble limestone, as are the walls, with the foundation being a continuation of the masonry wall system. Church records indicate that work was completed on the footings in 2007. The footings and foundations appear to be in good condition. (See Figure 20)

Figure 20: This photograph shows an area of floor structure repair. This gives a view of the inside of the foundation and the historic floor structure.

Recommendations: There are no indications that there are any problems, so no recommendations are made at this time.

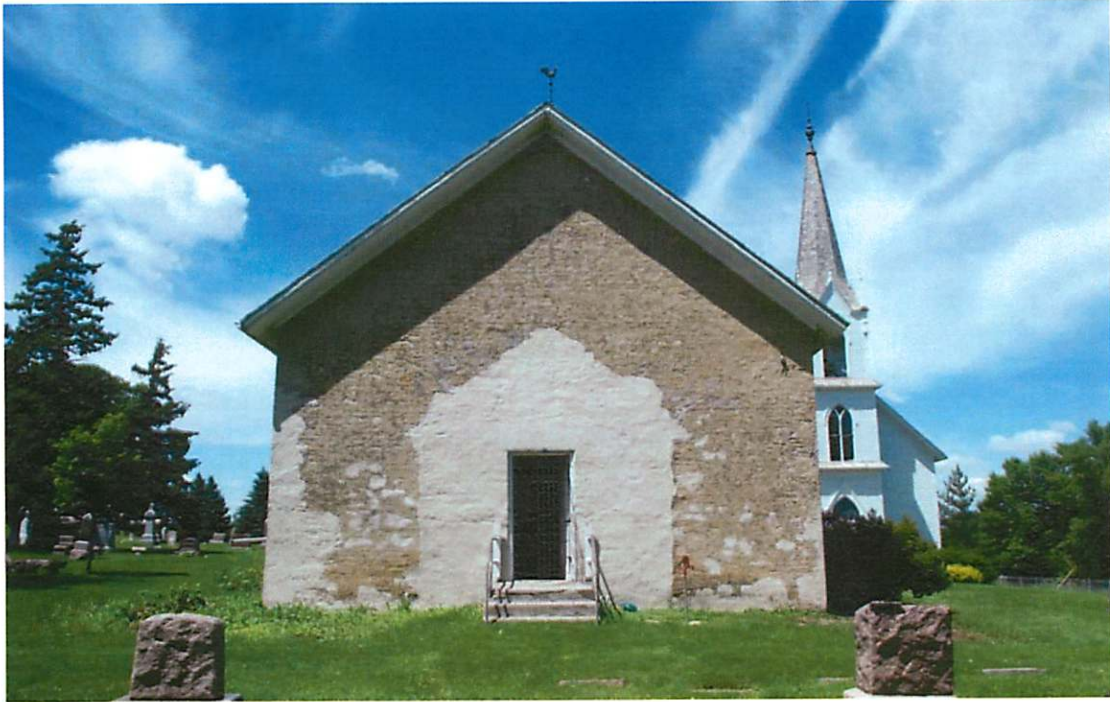
Assessment: The walls are constructed of rubble limestone which has been coated with a cementitious covering or plastering, inscribed with "mortar joints," creating the appearance of dressed stone units. It is unknown if this inscribed coating dates to the original construction of the church, but based on photographic evidence, it was clearly in place by the 1890s.³² There have been "repairs" made that are not sensitive to the existing wall and a poor match. There are areas that are deteriorating and should be repaired. Much of this deterioration has been caused by water infiltration, poor site drainage and age. (See Figure 21, 22, 23, & 24)

Assessment: The stoop and stair at the rear of the building are concrete. The stoop at the rear of the building is in poor condition. The concrete is deteriorated and cracked. The unit is pulling away from the structure, causing further damage, as the railing is connected to the wall. (See Figure 21)

Figure 21: This photograph of the rear of the Church shows the areas of masonry repairs that have been completed in the past. Note the concrete stair and stoop that are deteriorated.

Recommendations: Repoint underlining mortar joints and repair coating, returning mortar joints to the face of the wall. Care should be taken to provide a good match in terms of composition, aggregate, color, texture, and tooling. If possible, turn the stone stair upside down to see if the underside is in better condition. If not, replace stone stair, considering ADA accessibility and any changes that might be made in the future.

Recommendations: Provide a new concrete stoop and stair, with adequate footings and detailing to address the issue of frost heave and movement. Provide a landing at the bottom of the stair to terminate the handrail or provide a different detail.

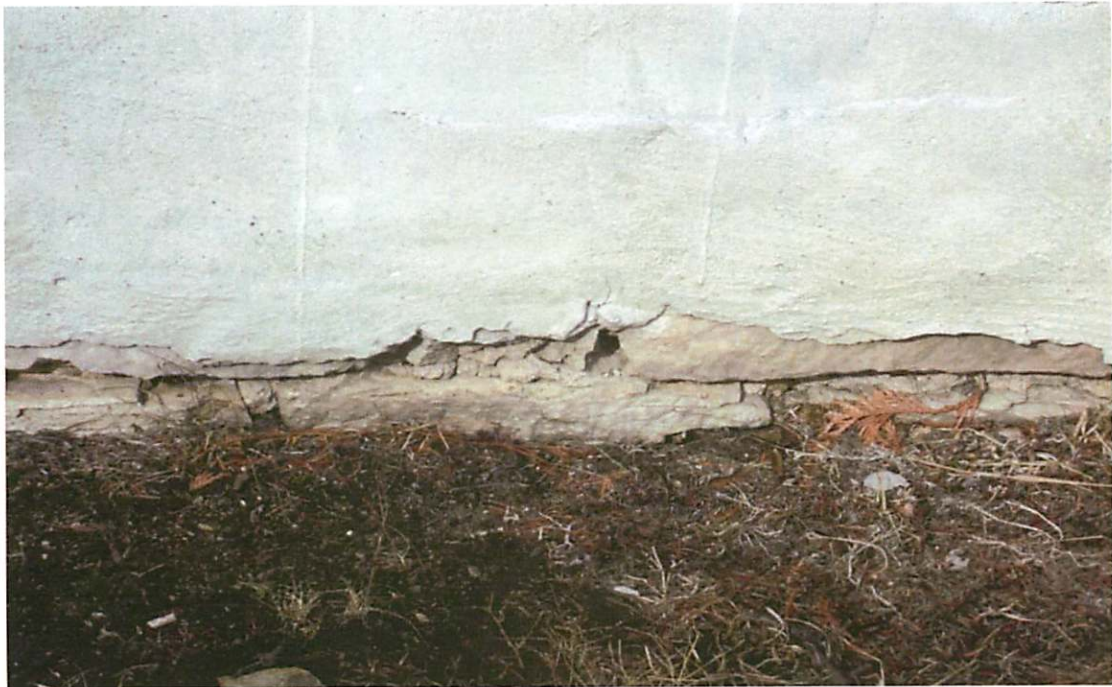
Figure 22: This photograph shows a close up view of an area that was patched, that is failing and the rubble stone wall beneath. Note the missing mortar at the mortar joints.

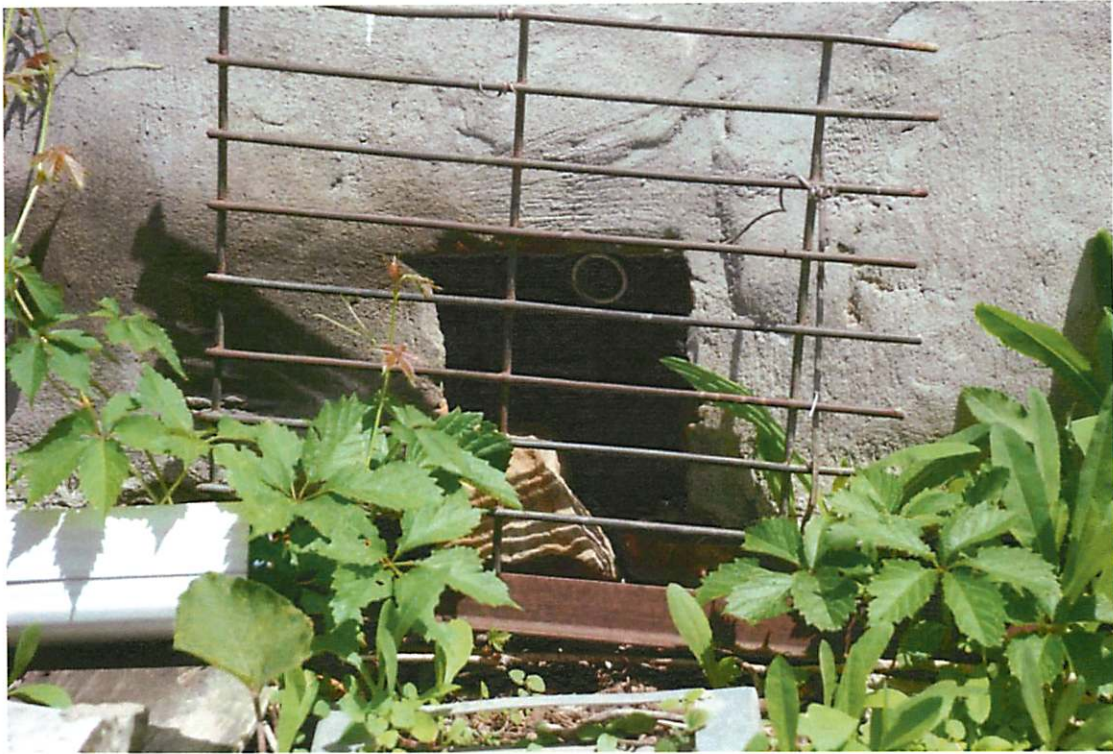
Figure 23: This photograph shows an opening at the foundation to the crawl space below. The grating that is in-place is not adequate to keep critters from occupying the space. Provide new grating within the opening to vent the crawl space but prevent entry.

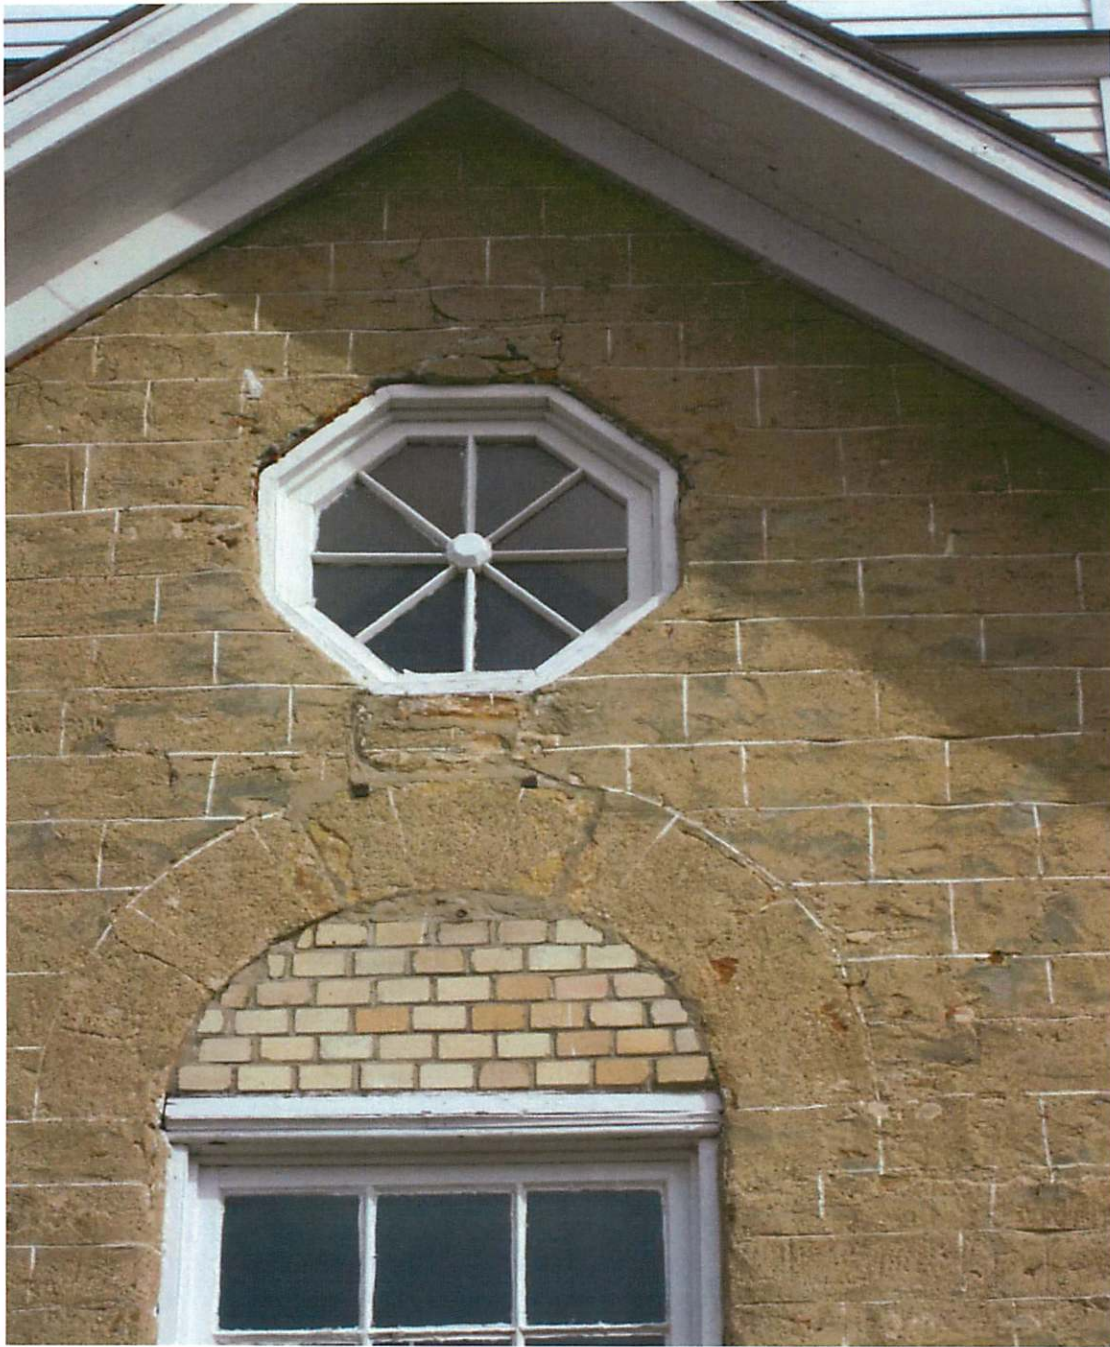
Figure 24: This photograph shows the upper windows at the front entry; historic photographs show that the brick portion above the windows would have been "plastered" as the walls.

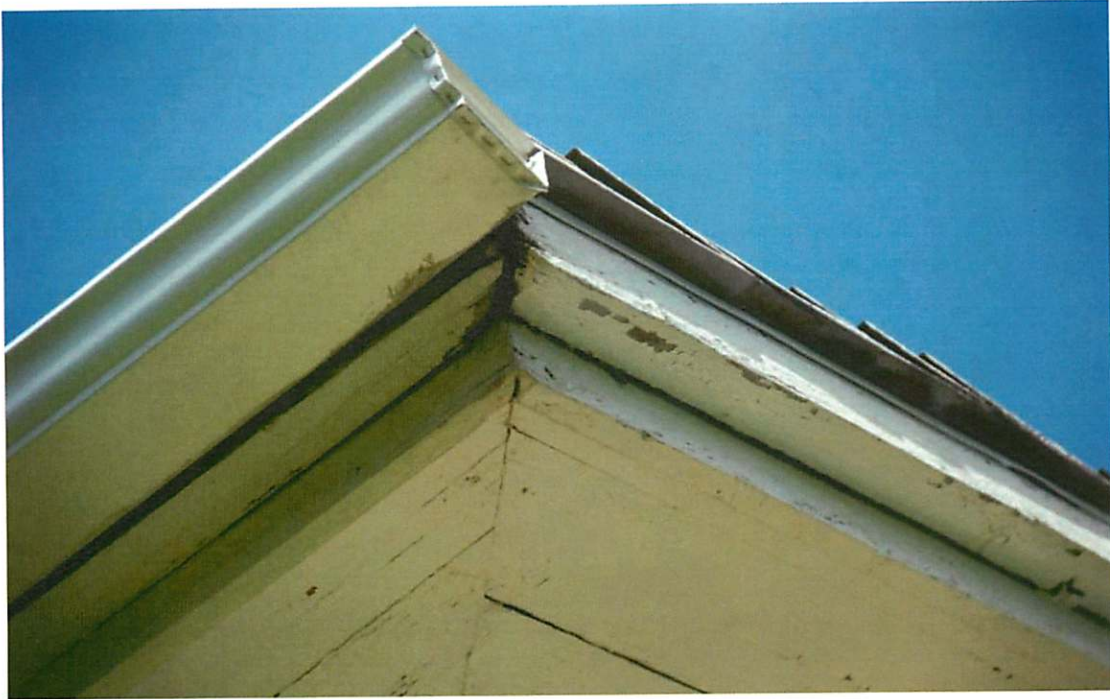
Assessment: The existing wood trim consists of painted soffit/eave ensemble at the roof edge and painted wood trim at the windows and doors. There are several areas that the wood is deteriorating and pulling apart at the joints, which allows for water infiltration. The paint is also deteriorating at these locations. (See Figure 25)

Figure 25: This photograph shows the corner intersection of the roof where the gutter ends. The wood trim is very deteriorated and the paint is failing.

Recommendations: Repair wood trim, seal joints and repaint.

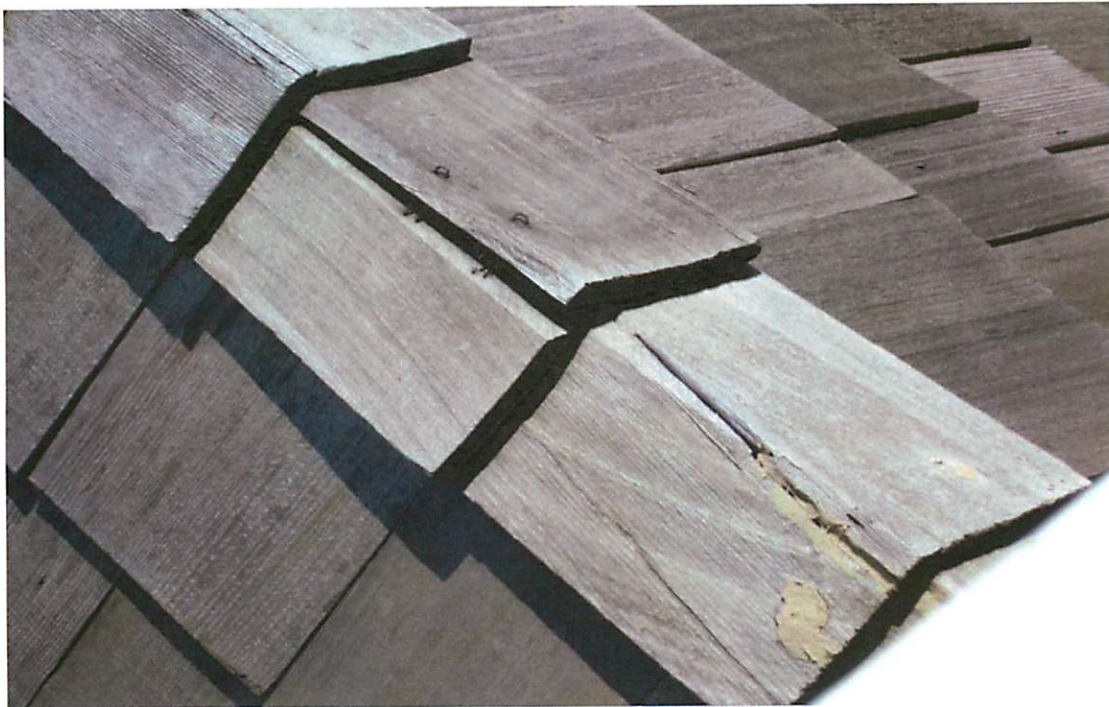
Assessment: There was a new cedar shingle roof installed in 2007. The roof clads the main gable portion of the structure and the conical steeple roof. It appears that the roof is in good condition. No flashing is visible. There is a membrane rubber roof at the steeple, installed in 2005. (See Figure 28) There are a few areas where shingles have come loose or are pulling apart, such as at the roof ridge. (See Figure 26) Also, some of the shingles are starting to cup.

Figure 26: This photograph shows a portion of the roof ridge where the shingles are pulling apart. It appears that a repair had been previously attempted.

Recommendations: Periodically inspect the roof to monitor condition. Replace damaged shingles.

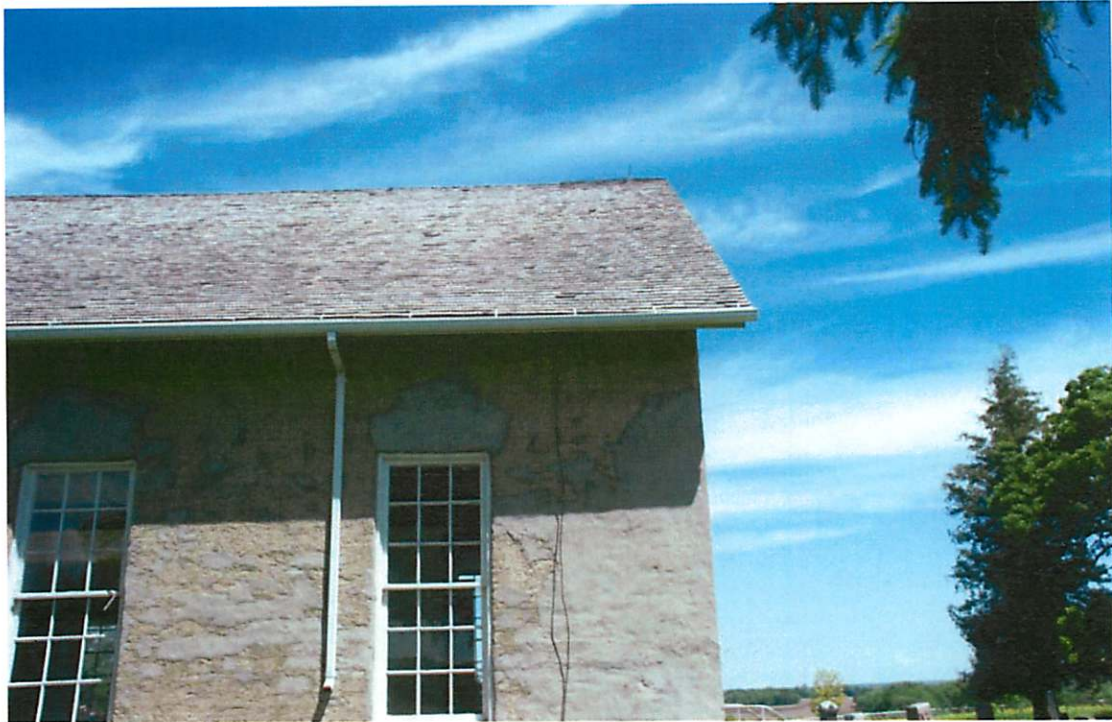
Assessment: There are gutters or downspouts installed on the north façade of the building. The gutter appears to be in good condition, but the downspouts are too short. In one location, the gutter does not even reach the ground level. (See Figure 27) Historic photographs do not indicate that gutters had previously been installed.

Figure 27: This photograph shows the gutter and one downspout on the north façade. Note the short length of downspout that allows water to drain down the side of the wall and not away from the building.

Recommendations: Care needs to be taken to maintain downspouts, either with a rain barrel or in conjunction with lawn mowing. Downspouts need to be in place to drain water away from the grade. Care should be taken to reattach after mowing and not to run over them with equipment. Remove any plant materials that are close to the foundation and that hold water against the building. Slope grade away from the building.
