HISTORIC STRUCTURE REPORT
for the
VALLEY GROVE CHURCHES
Nerstrand, Minnesota

prepared for the
VALLEY GROVE PRESERVATION SOCIETY

prepared by
MacDonald & Mack Architects, LTD.
400 South Fourth Street, Suite 712
Minneapolis, Minnesota 55415

September 30, 2013

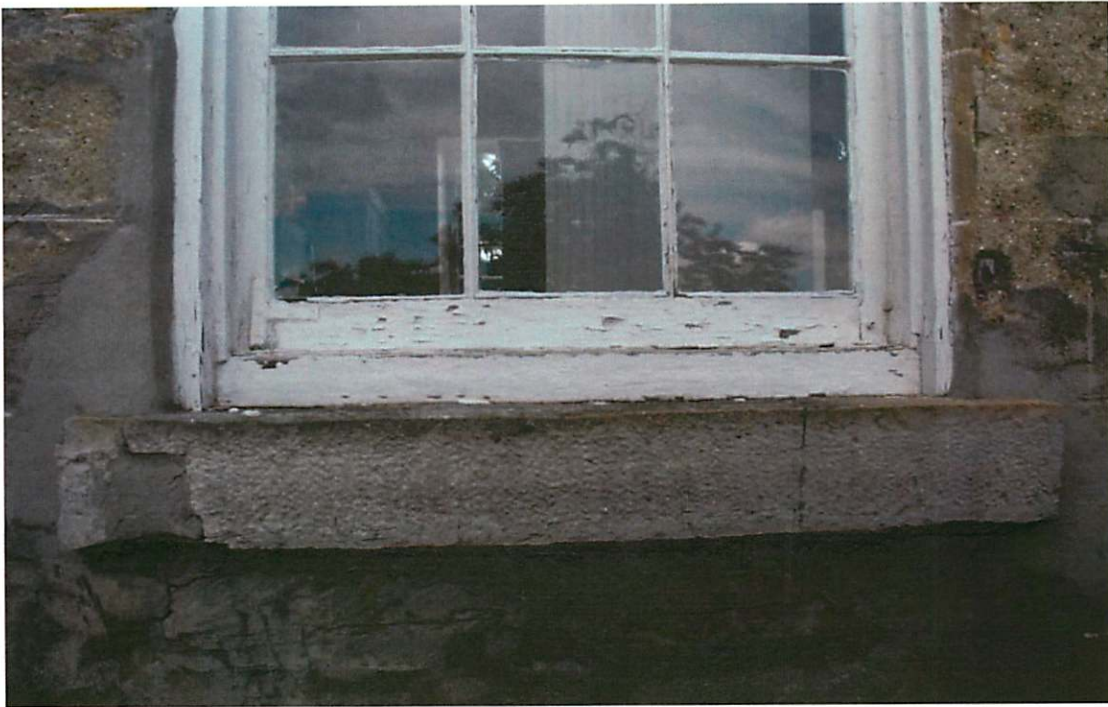
Many of the limestone window sills are deteriorating; cracking and missing material is common. There are some areas that have been repaired with concrete, a patch that does not match in color, texture, or material.

Assessment: There are painted nine-over-nine double-hung sash windows at the north and south façades of the church. There is a single painted nine-over-nine double hung sash window above the front door, above this window is a small hexagonal divided light window at the attic level. (See Figure 24) Careful examination of the windows indicates that some windows are of an earlier age than others, based on muntin width, which varies among windows. The windows are in poor to good condition. (See Figure 29 & 30) The joint between the window and the masonry wall is undefined at many locations, the “plastering” covers the wood trim.

Figure 29: This photograph show typical window condition: cracked and deteriorated stone sill, deteriorated frame and sash, cracked or missing glazing putty, and deteriorated paint.

Repair limestone window sills with masonry epoxies at the cracks and masonry patch materials that match the existing stone. It is desirable to maintain the existing material rather than replace the stone sills.

Recommendations: Care should be taken to repair the window, including frames, trim, and sash. Maintain as much of the historic material as possible; the use of wood epoxies is recommended. Windows should be re-glazed using new putty and the existing glass lights. Any replacement should match the species of wood, as well as the profiles and sizes of the existing windows. When work is performed, care should be taken in re-establishing a clean joint between the wood and masonry.

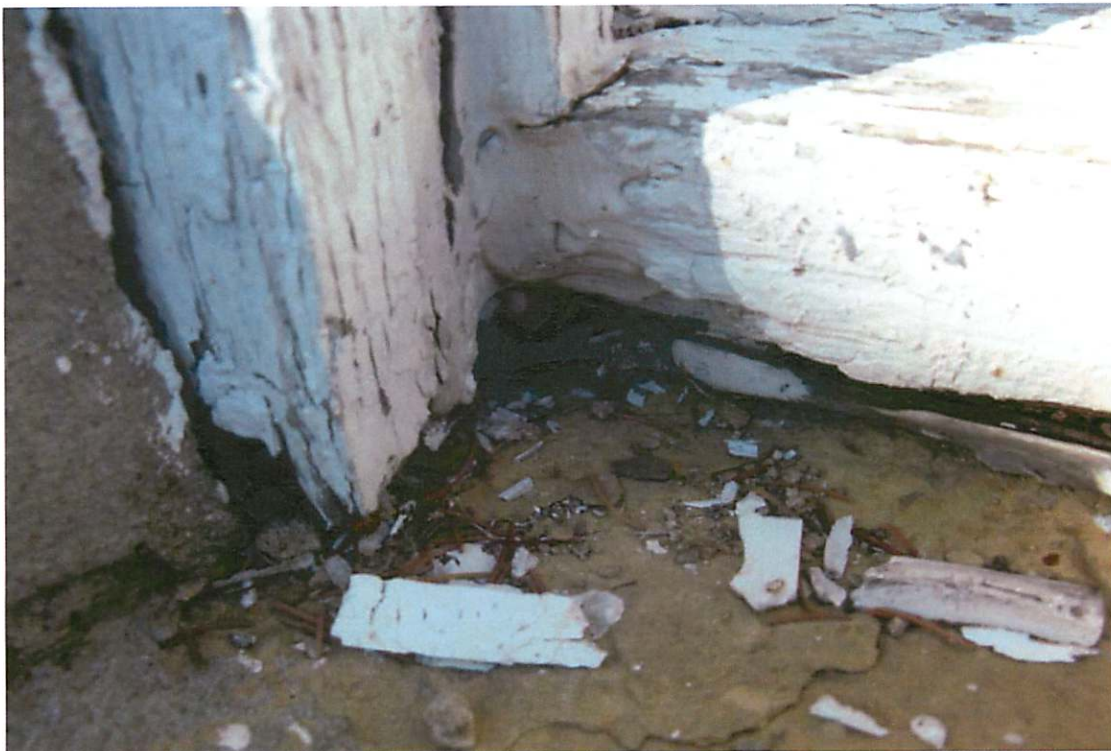
Figure 30: This is a close up view of the corner of a window frame and sash.

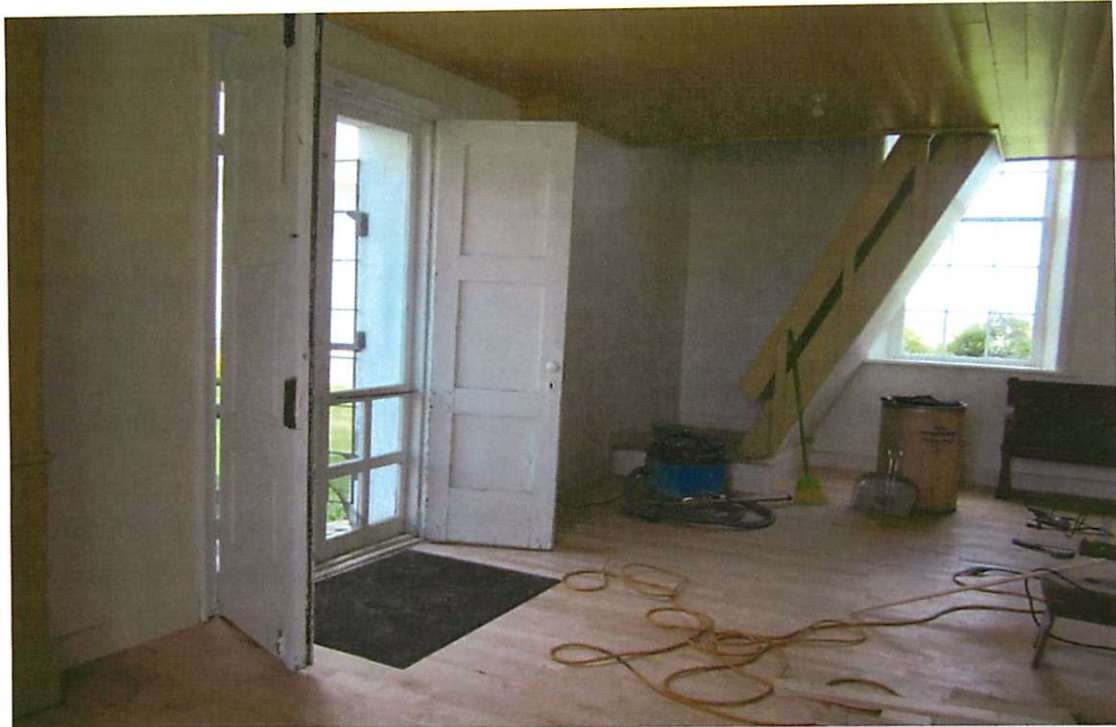
Assessment: There is a wood ship ladder to access the second level of the building. The ladder is sound construction and in good condition but does not meet building code requirements for public access to the second floor balcony. The ladder was installed in 2008, according to church records. (See Figure 31)

Figure 31: This photographs show the interior of the 1864 Church, near the front entry. The ships ladder at the back leads to the balcony level.

Recommendations: It is not known if the ladder is based on historic precedent, but if it is, maintaining the existing ladder and limiting public access is recommended. If the use requirements of the space change, careful consideration should be given to alterations.

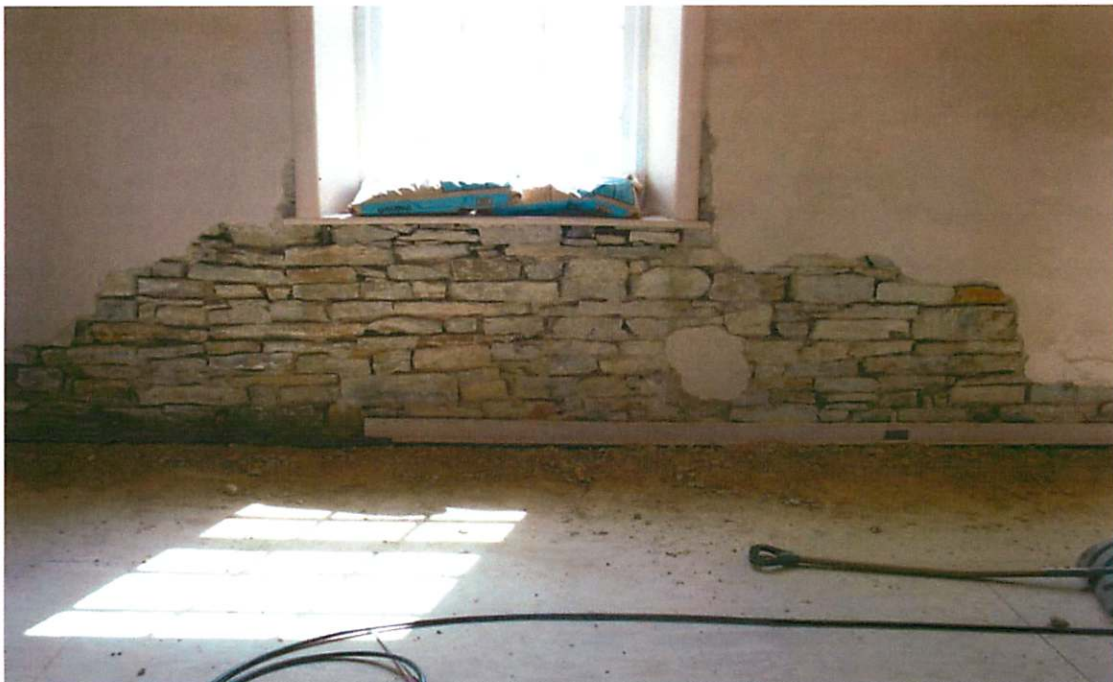
Assessment: The interior walls are the exterior stone wall and are in good condition. Church records indicate that interior wall tuckpointing, plastering, and painting were completed in 2008. (See Figure 32) The interior wall is wood-framed, clad with painted bead-board, and provides a separation between the main space and kitchen area. (See Figure 35)

Figure 32: This photograph shows interior of the wall with a portion of the plaster removed, the masonry was repointed and the wall re-plastered. This gives some indication of what the exterior walls may look like without the "exterior plastering".

Recommendations: Periodically inspect wall surfaces. Clean rather than paint to maintain appearance.
