HISTORIC STRUCTURE REPORT
for the
VALLEY GROVE CHURCHES
Nerstrand, Minnesota

prepared for the
VALLEY GROVE PRESERVATION SOCIETY

prepared by
MacDonald & Mack Architects, LTD.
400 South Fourth Street, Suite 712
Minneapolis, Minnesota 55415

September 30, 2013

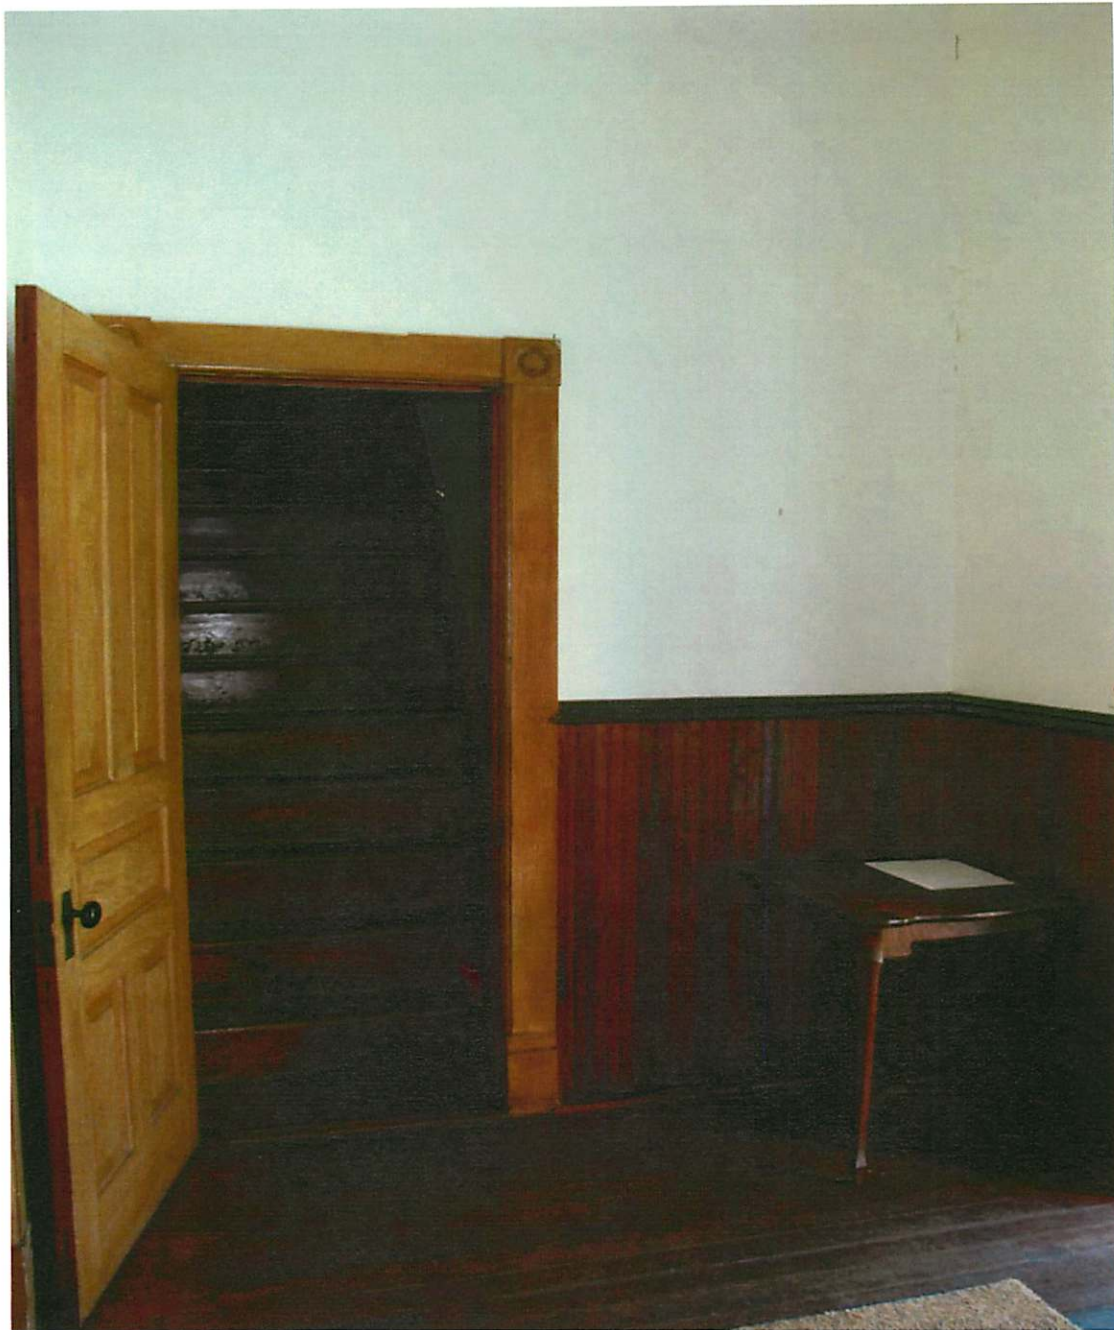
Assessment: The existing stair provides access to the choir loft and bell tower rope. The stairs are unpainted, with a similar finish as the rest of the interior wood. At the top of the stairs there is a turned balustrade, similar to the one at the altar. The wood stair is in good condition. (See Figure 13)

Figure 13: This photograph shows the front entry and the stairs to the balcony. Note the bead-board wainscot, and the five paneled wood door and wood floor.

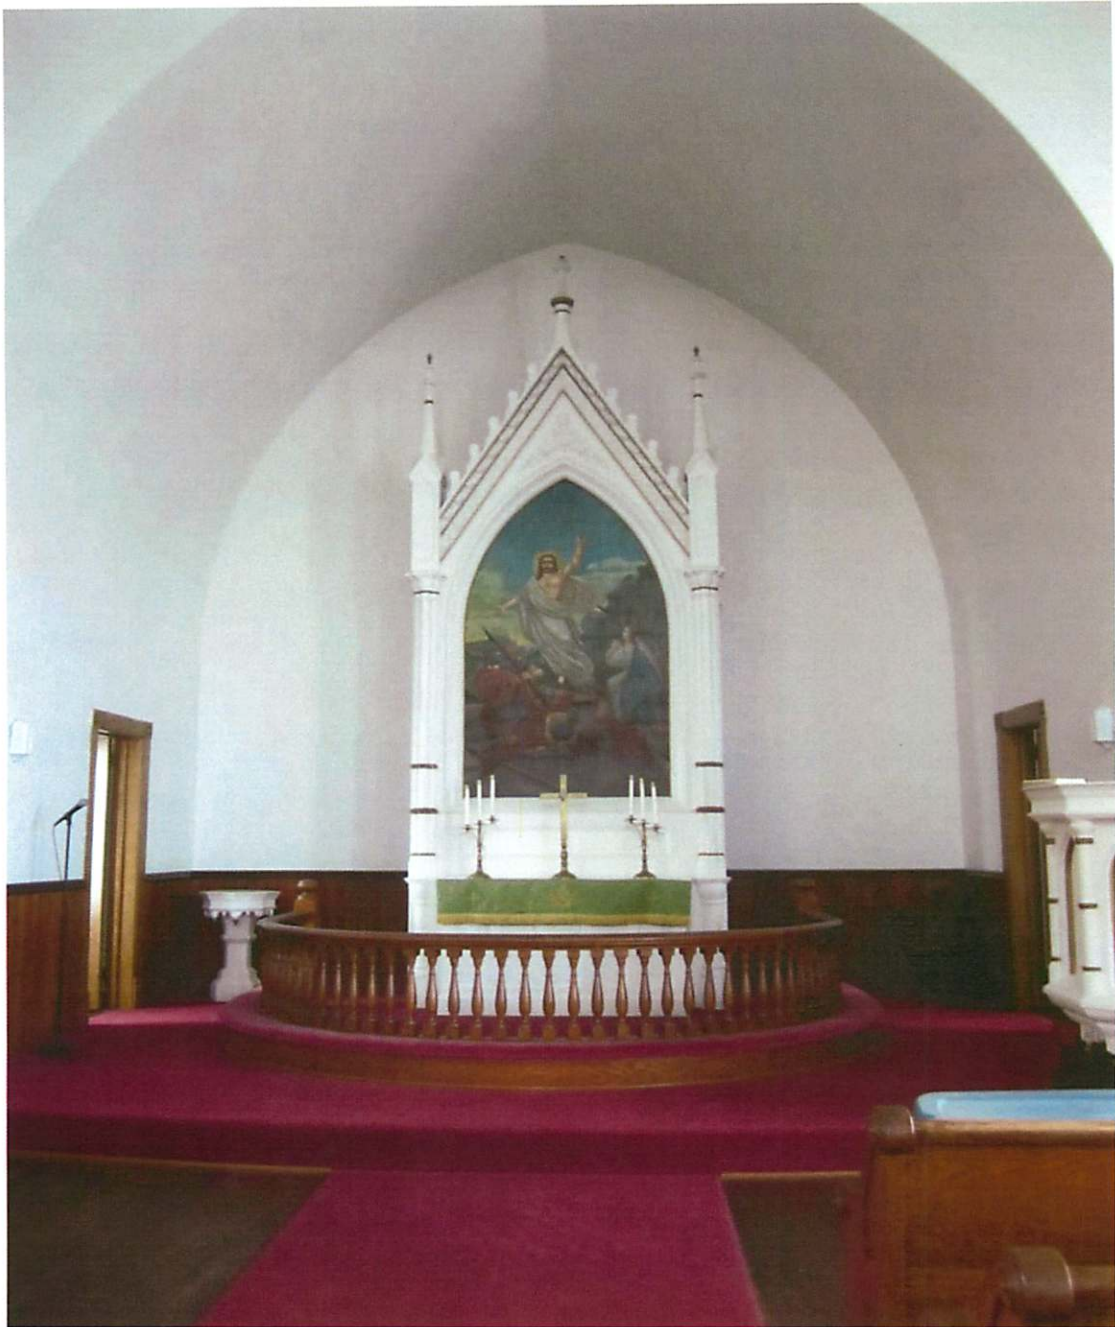
Assessment: The existing sanctuary walls are painted plaster with a varnished bead-board wainscot. The entry vestibule has painted bead-board walls. Church records indicate that the chancel was "re-rocked" in 1992. The two small back rooms have wallpaper over plaster. Generally the walls are in fairly good condition with some areas of wear. (See Figure 14)

Figure 14: This photograph shows the chancel area of the sanctuary.

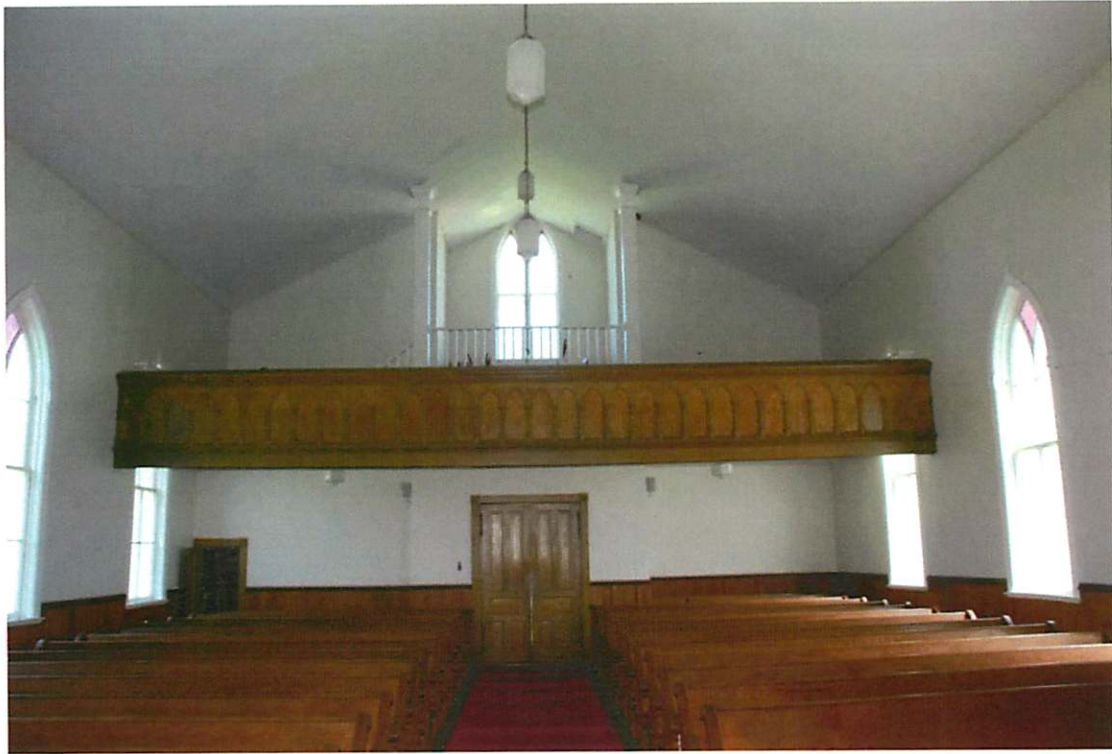
Assessment: The existing wood trim is located primarily at the chancel, organ and balcony. The wood has a transparent finish and is in good condition. There is also painted wood trim at the windows and the pulpit. Some of the window trim has a deteriorated paint finish. (See Figure 15)

Figure 15: This photograph is looking back to the front entry, showing the balcony above.

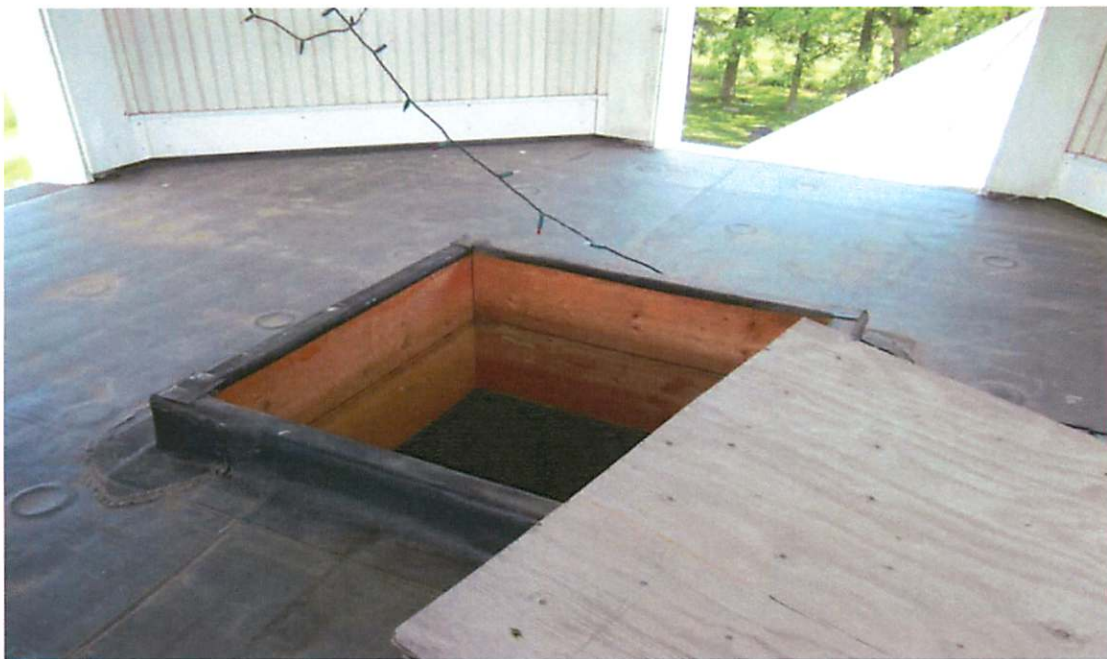
Assessment: There was a new cedar shingle roof installed in 2007. The roof clads the main gable portion of the structure and the conical steeple roof. It appears that the roof is in good condition. No flashing is visible. There is a membrane rubber roof at the steeple, installed in 2005. (See Figure 28) There are a few areas where shingles have come loose or are pulling apart, such as at the roof ridge. (See Figure 26) Also, some of the shingles are starting to cup.

Figure 28: This photograph show the membrane roof and access hatch at the cupola level.

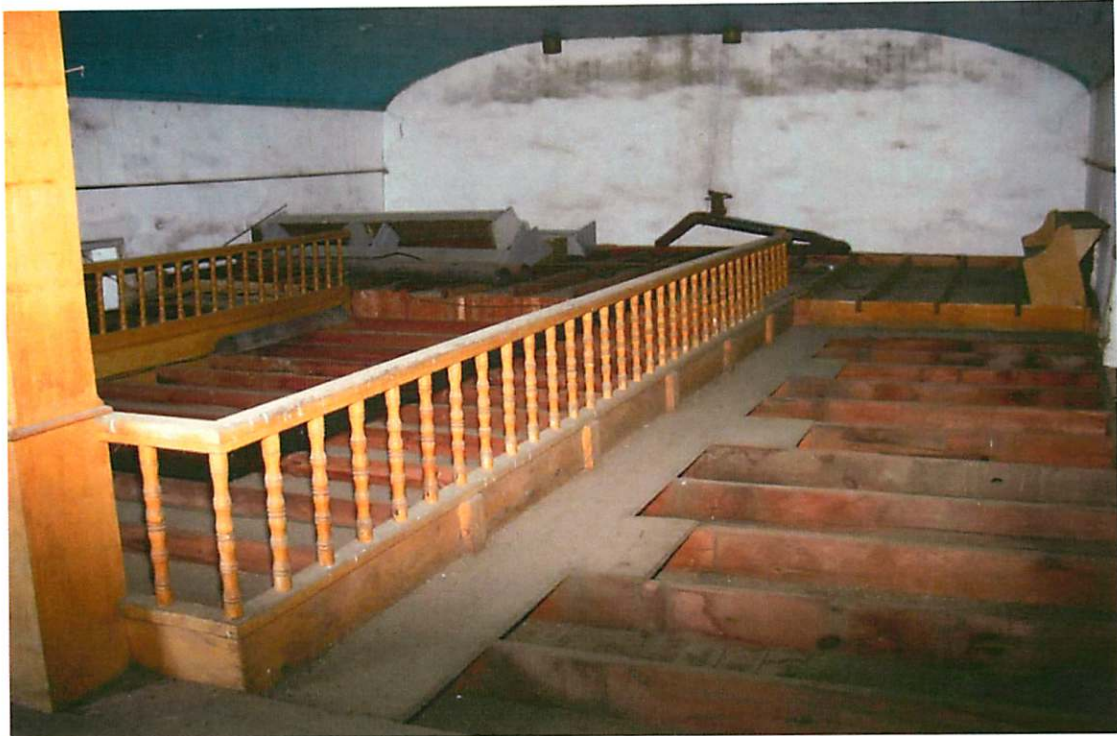
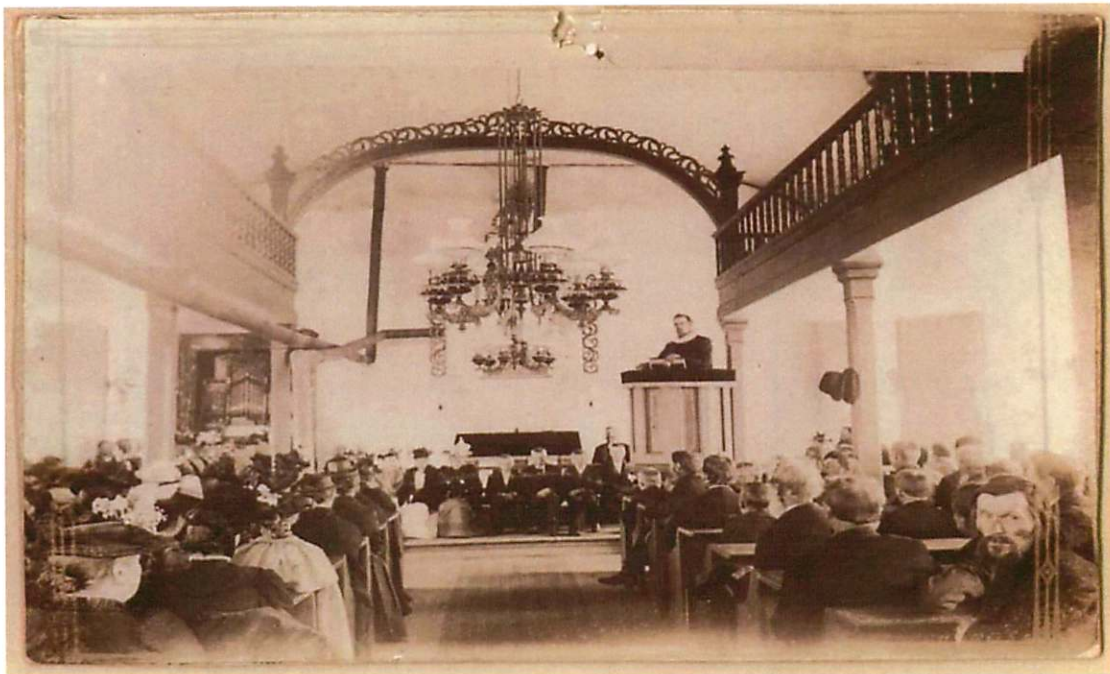
Assessment: The existing wood work and trim in the interior is the balcony system, which has painted wood columns supporting the floor level, with a wood balustrade surrounding the edge of the loft. The windows have painted wood trim, which is in good condition. (See Figures 33 & 34)

Figure 33: This photograph shows the balcony level before the ceiling between the railing was removed.

Figure 34: This historic view of the interior shows the balcony open to the ceiling above.

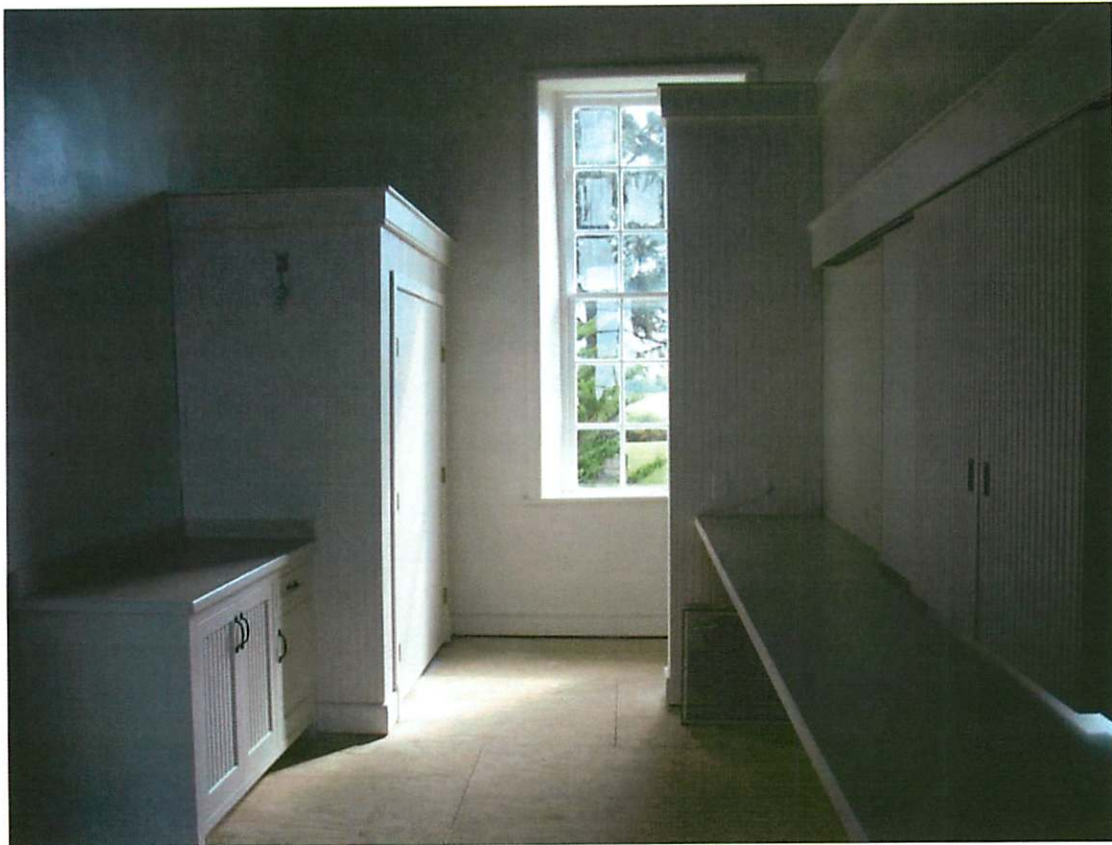
Assessment: The interior walls are the exterior stone wall and are in good condition. Church records indicate that interior wall tuckpointing, plastering, and painting were completed in 2008. (See Figure 32) The interior wall is wood-framed, clad with painted bead-board, and provides a separation between the main space and kitchen area. (See Figure 35)

Figure 35: This photograph shows the “kitchen” area, located behind the screen wall to the right.

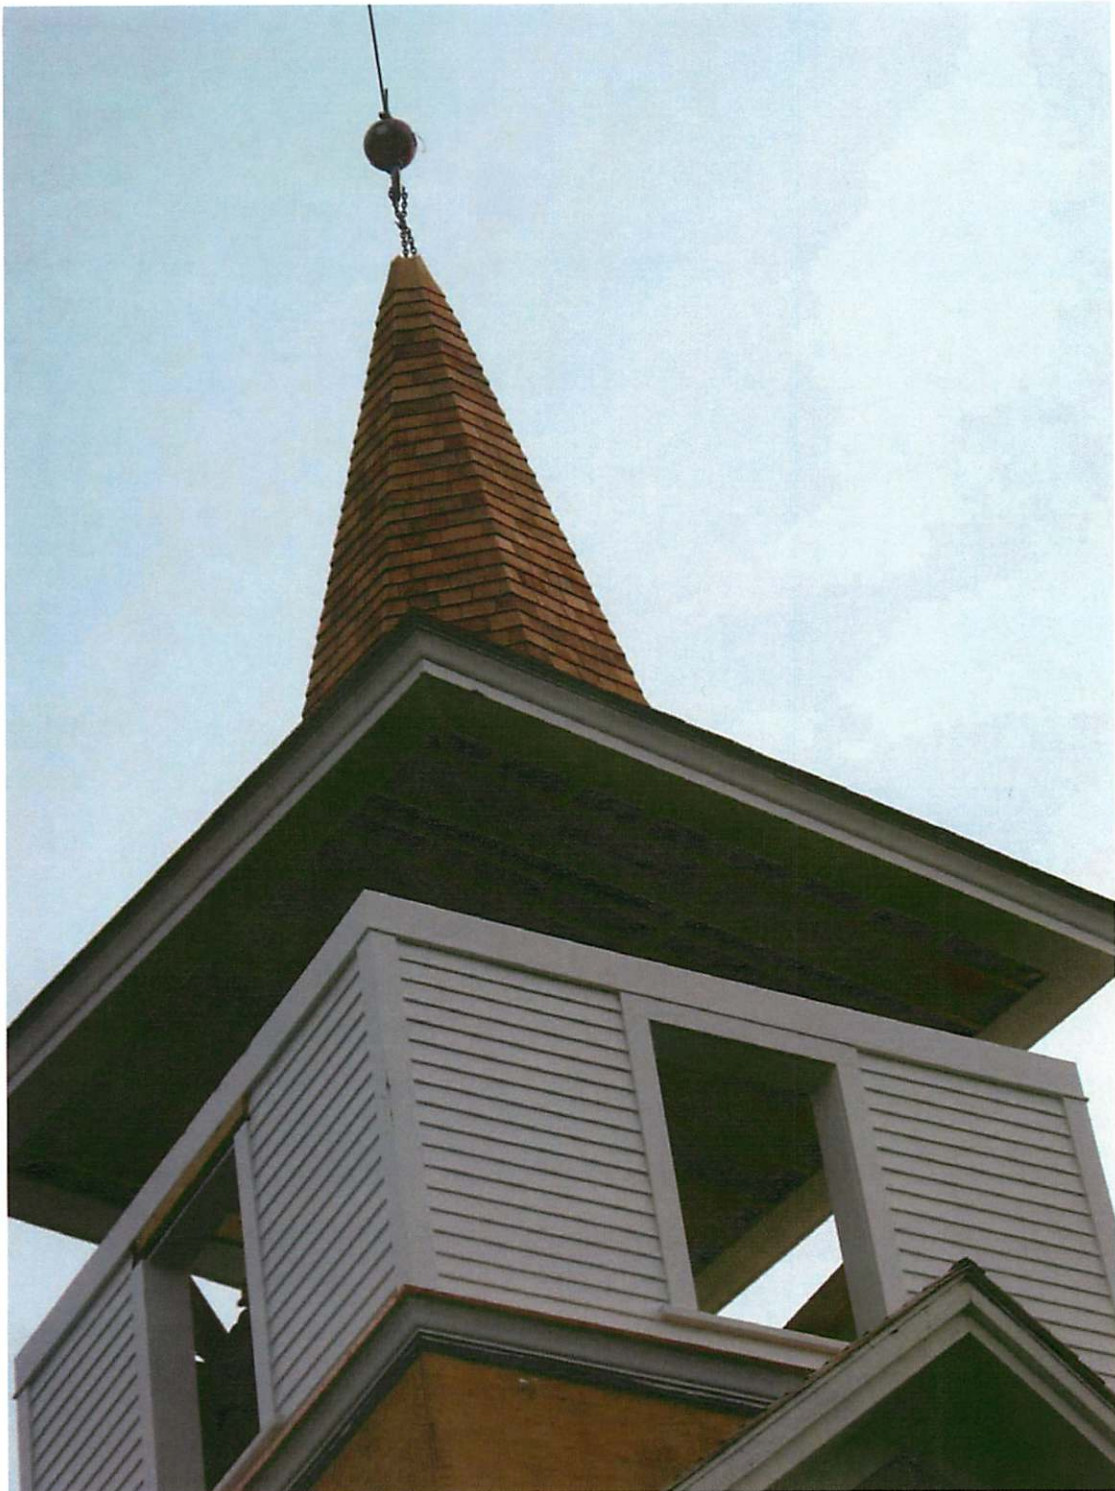
Assessment: Historic photographs from in the Valley Grove Preservation Society archives show that the steeple was been modified over time. In 2007, the current steeple was installed, based on historic photographs; it remains in good condition. (See Figure 36)

Figure 36: This photograph shows the new cupola structure being installed. The cupola is all new material.
